December 13, 2021

The Herrera team has evaluated a range of recommended actions for Camp Colman in response to the WDNR Restoration of Whiteman Cove. The recommended actions were identified based on our earlier assessment of risks to the Camp Colman property, meetings with YMCA staff, and the Needs Assessment provided by Kaleidoscope. Each opportunity was evaluated, described in concept, and includes additional supporting information relevant to your consideration and future planning for the Camp.

The Washington State Department of Natural Resources (WDNR) plans to conduct a large-scale restoration of the historical tidal channel that blocked tidal flow and fish passage between Case Inlet and Whiteman Cove. This restoration will enable the State of Washington to meet the needs of the 2013 federal court ruling *United States v Washington*, and the State of Washington's obligation under treaty agreements with 21 tribes to protect and preserve tribal fishing rights, including tide gate removal and restoration. WDFW installed tide gates and impounded the Whiteman Cove lagoon to develop a fish hatchery in the 1960s. The tide channel was filled, and tide gates were installed on the roa

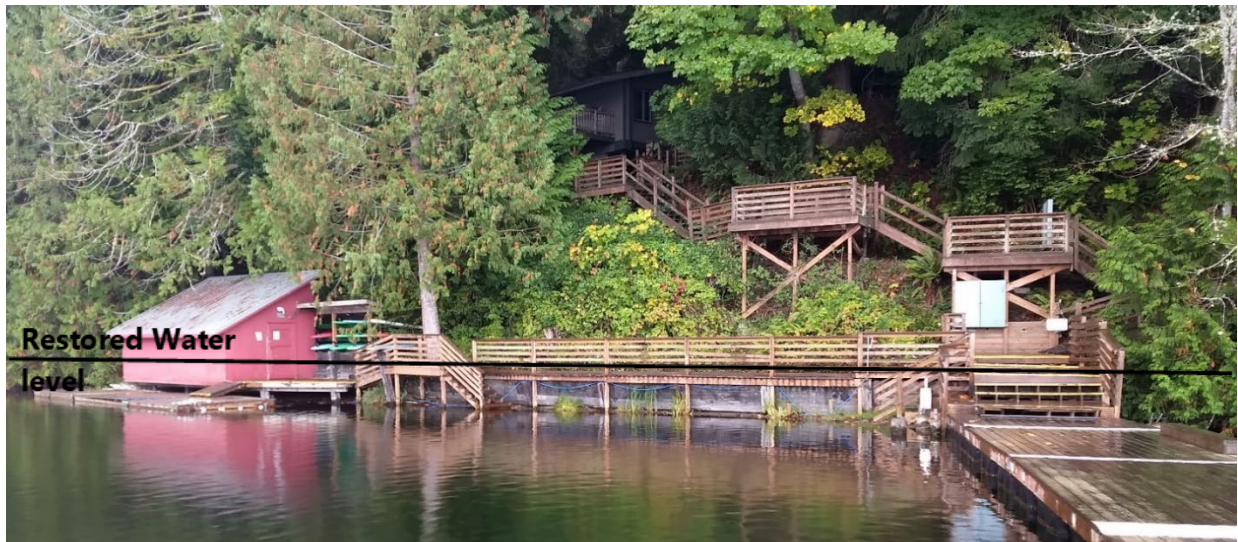
Figure ES-1. Gangway, Decking, and Access Stairs Will Need to be Rebuilt to Accommodate Restored Water Level.

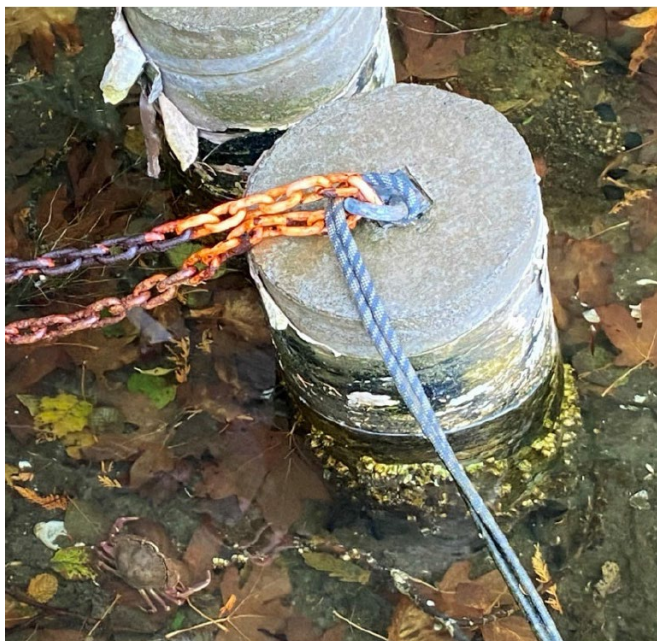
Figure ES-2. Existing Concrete Anchors Used to Secure the Lagoon Dock.

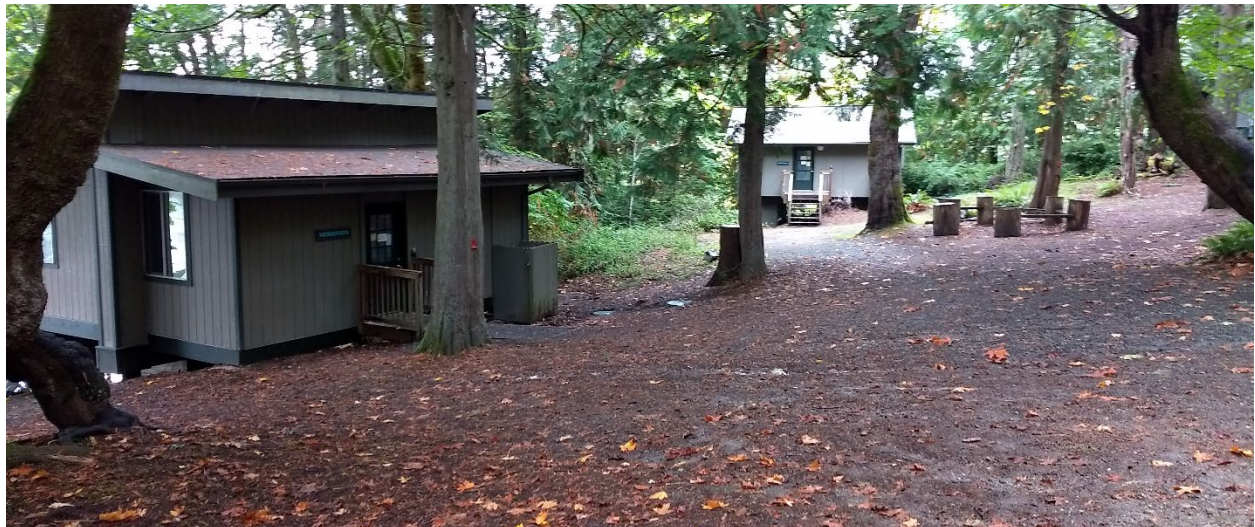
Figure 4. Henderson and Rotary Cabins Near the Bluff Crest.

Cabins and the onsite wastewater pump station that are near the bluff crest should be relocated farther landward to address the human health risk of bluff failure while the cabins are occupied (Figures 3 and 4). These structures should first be evaluated to determine if relocating is necessary or if structure demolition and rebuilding is a more appropriate option. Of primary concern is Henderson, Rotary, and Calvin cabins, which already exhibit signs of soil creep around them (e.g., tree bases bent toward the water). Relocation entails preparing a new location through clearing a pad, building a new foundation, providing utility connections, lifting the cabins off their foundations and transporting them to the new site, and demolishing the old foundation and utilities and restoring the former location. Moving a serviceable building is typically a more significant cost savings compared to new construction. Relocating the onsite wastewater pump station will also require relocating the associated plumbing and electrical to the new location and making sure its sufficiently downslope from the lowest cabin.

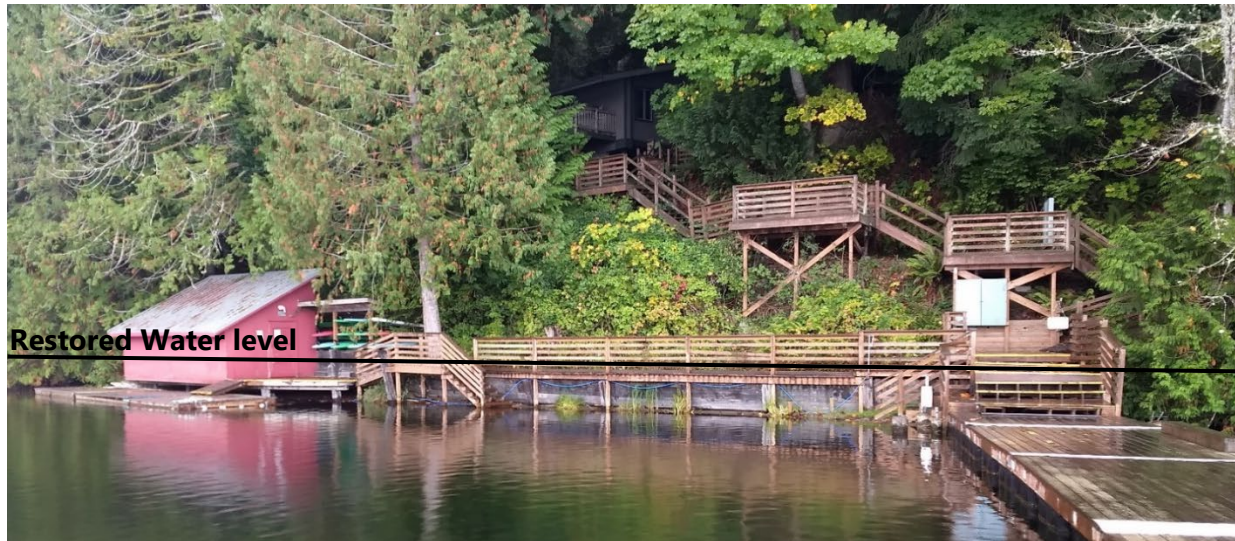
The access stairway to the Whiteman Cove aquatics program area should be rebuilt to strengthen its footings and potentially repositioned to traverse a less steep area, as the bluff face is very steep and vulnerable to future erosion following restoration. The base of the access stairway will be inundated by tides regularly, and so should be removed (Figure 5). This would include the walkway to the boat storage building, which should also be replaced. Much of the

existing stairs decking appears to be in good condition and may be simply reset on new, deeper foundations. Modifying the shoreline access assumes that the existing dock and shoreline trail locations will continue to be used in the future.

Figure 5. Gangway, Decking, and Access Stairs Will Need to be Rebuilt to Accommodate Restored Water Level.

An improved foundation system for the stairway and decks will have to be designed to provide more stability. Some options for this include helical piles or small-diameter pin piles that can be driven in with portable machinery, an important factor on steep slopes. If helical or small pin piles are not an option, more complex solutions may need to be developed. Geotechnical investigations will be key in determining which method works best in the existing location or if a nearby alternative should be found.

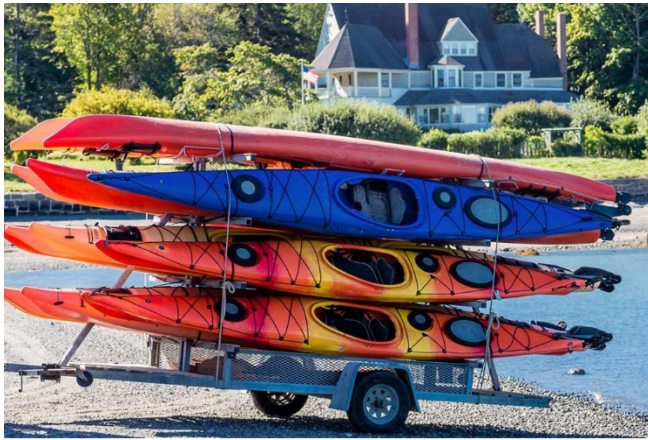
Figure 6. Example of Mobile Kayak Storage, Capable of Being Moved to Wherever the Boats will be Used.

The existing boat house on the lagoon will be regularly flooded following restoration and should be moved. While the existing structure could be moved or a new building built, restoration provides an opportunity to reimagine the storage of the Camp's boats in a way that is more flexible for boating inside and outside the lagoon. A mobile storage wrack could be moved to the spit to access Case Inlet or to Camp Taylor for classes in the pool (Figure 6). The mobile storage could then be parked under cover during the off season.

A mobile boat storage option could easily be parked anywhere on the camp, assuming at least one Camp Colman vehicle has a trailer hitch. Covered off-season storage could be built, or more simply, the boats could be parked and covered with tarps. Aside from demolition of the existing boat house, mobile storage options could be easily acquired and require very little planning and no permitting.

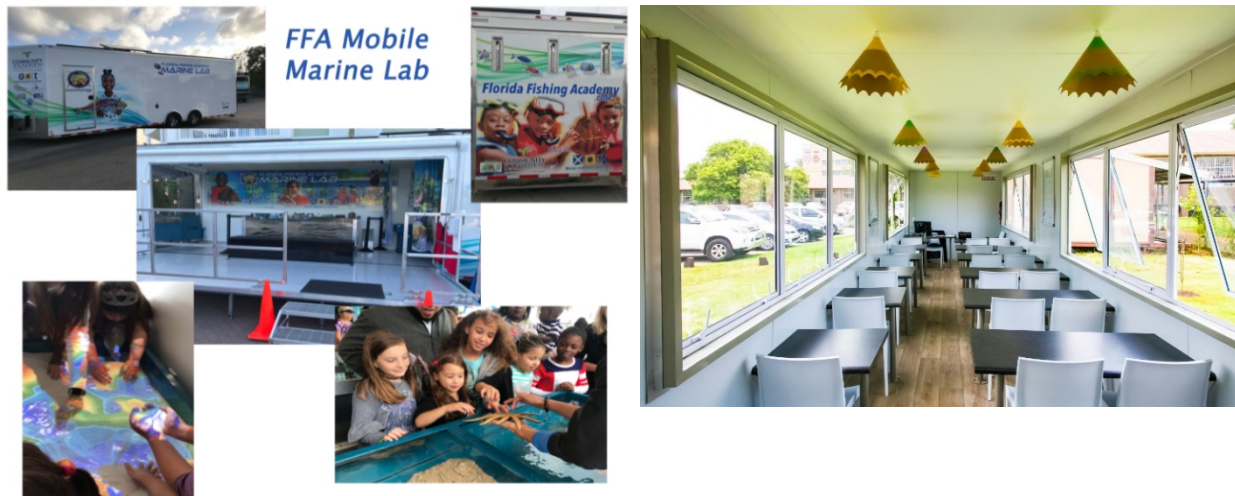
Figure 7 shows some snapshots of [a similar mobile marine lab](#) concept developed by the Florida Fishing Association. Additional imagery is available on their website and Facebook account. They funded the marine lab through a local grant program; and the total cost shared below included the cost of the touch-tank, generator (not necessary for all applications), trailer conversion, 10 solar panels with batteries, a truck capable of towing the trailer, and a sand box.

Figure 7. Examples of a Mobile Marine Lab Trailer (left) or Mobile Classroom Constructed from an [Adapted Storage Container](#) (right).

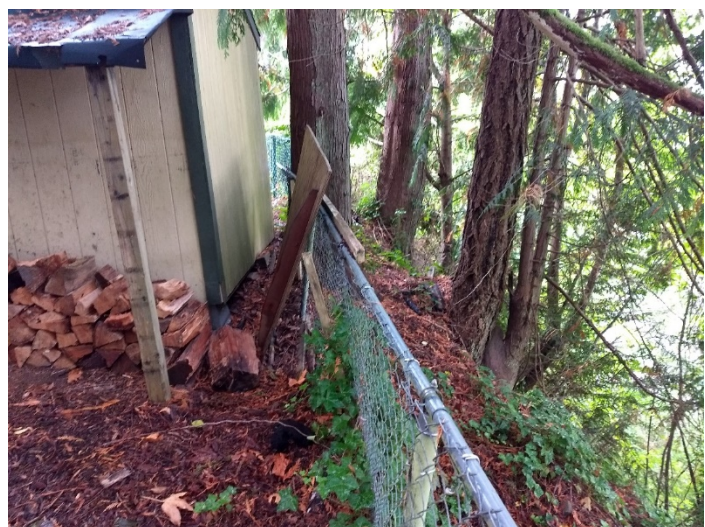
Figure 8. Shed at the Firepit, Very Close to the Edge of an Undermined Bluff.

The campfire ring, stage, and shed should be relocated to a location further landward from the bluff crest (Figure 8). Although the toe of bluff is currently not exposed to marine waters, it will be following restoration during high tides and high-water events. With the stage and shed located at the bluff crest with and foundation to help stabilize them, they are particularly vulnerable to landslides and slope instability.

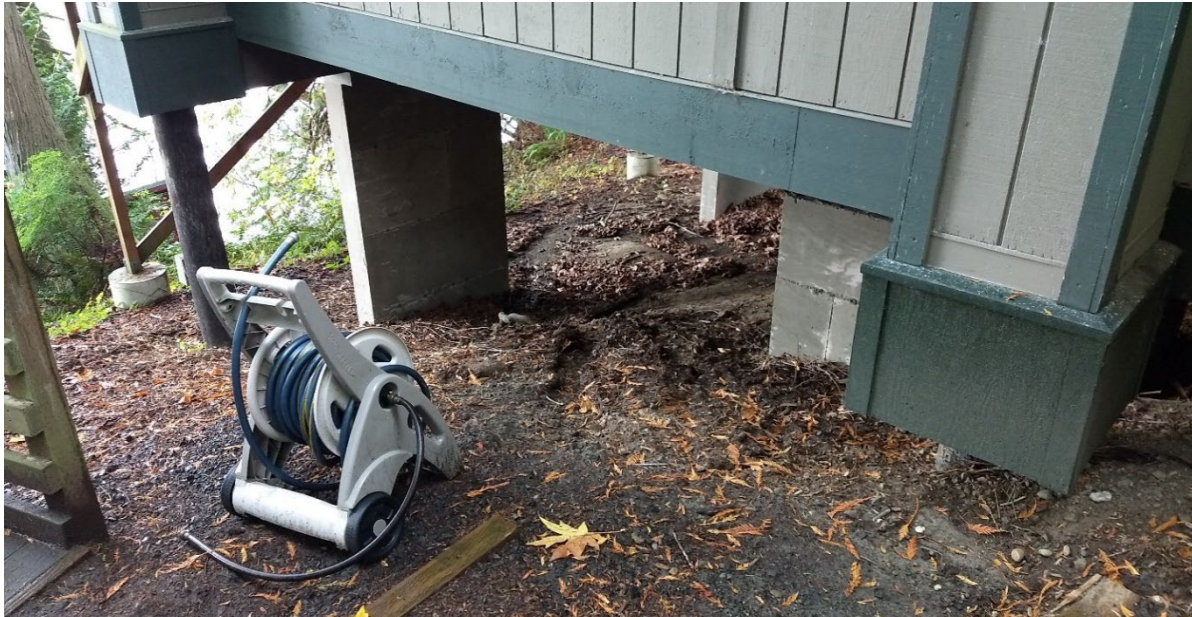
The combination of uncontrolled sheet flow and shallow concentrated stormwater flows, shallow groundwater, documented poor permeability of the underlying geology, and presence of soils that are vulnerable to erosion suggests that improved stormwater management is necessary to reduce erosion hazards, see Figure 9. Water from gutters, cleared areas, trails, and parking lots should not allowed to flow directly toward and down the bluff face but should be collected and conveyed to the toe of the bluff or dispersed in areas that will not exacerbate erosion hazards. dissipated in areas with low slopes and dense upland vegetation or tightlined directly to base of the bluff.

Figure 9. Rills from Stormwater Flowing Down the Uplands to the Bluff Face.

To implement proper stormwater management, first a plan will need to be developed. Next a system to convey stormwater flows in the core camp area to the toe of the bluff will need to be installed. Then other stormwater improvements will need to be implemented as per the plan that is developed.

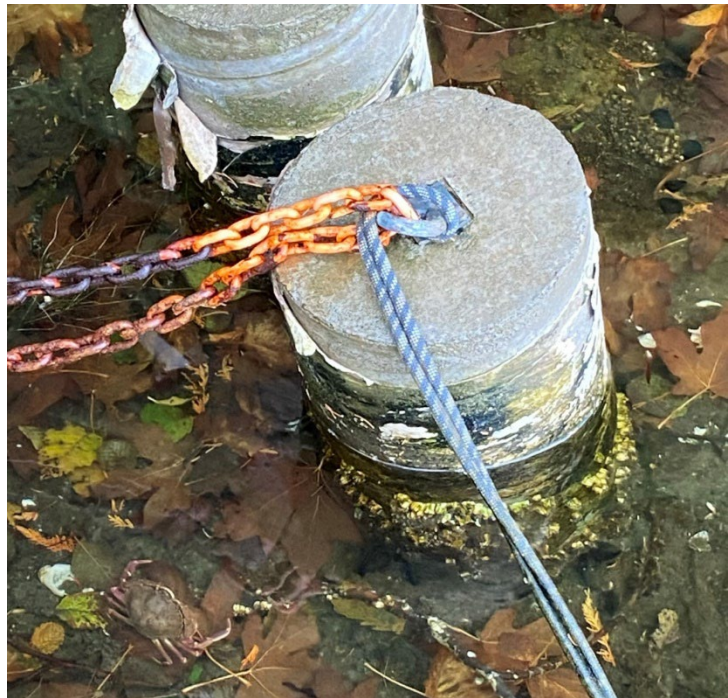
Figure 10. Existing Concrete Anchors Used to Secure the Lagoon Dock.

Restoration of tidal fluctuation with Whiteman Cove will immediately impact the functionality of the existing dock, so adaptation of the dock should happen prior to or during restoration. The dock current appears functional and may be reused with little change other than how it is kept in place. Geotechnical investigations will be required to determine pile size, location, and depth. Permitting of pile-driving activities within marine environments can be done but will take time and usually require marine mammal monitoring during construction to prevent disturbance, particularly of whales.

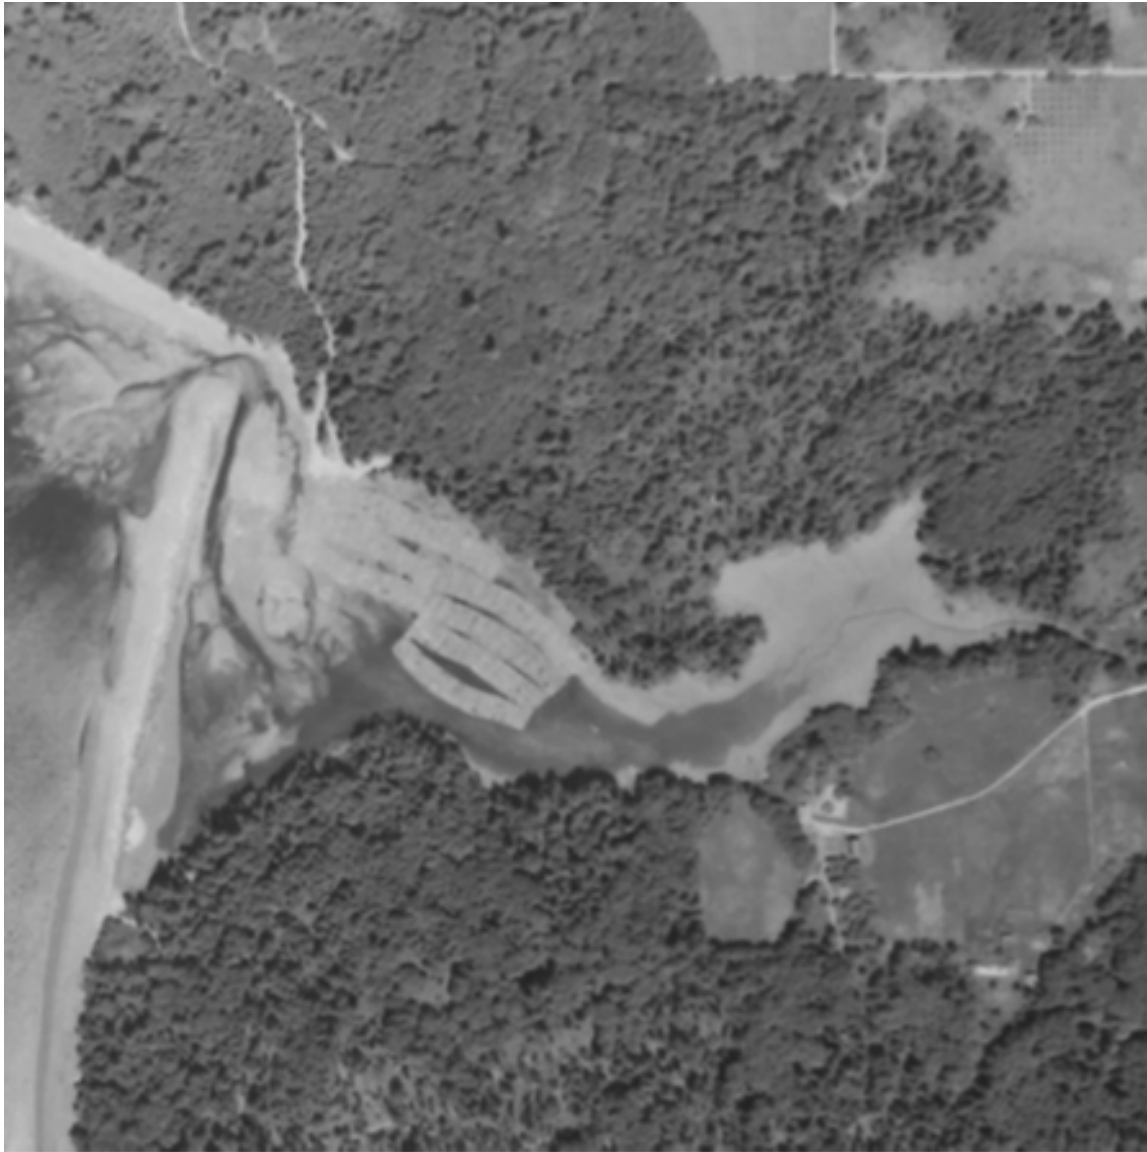
Figure 2. 1955 Aerial Image, Whiteman Cove (USGS).

Prior to the 1960's, Whiteman Cove functioned as a tidally-influenced barrier estuarine lagoon with a tidal channel connecting the lagoon (Whiteman Cove) to Case Inlet (Figure 2). This tide channel was closed off in 1962 by the Washington Department of Fisheries in order to create a saltwater lake (also described as a "perched brackish water lagoon") suitable for rearing juvenile salmon (DNR, 2021; Figure 3). An intermittent freshwater stream outlets to Whiteman Cove's eastern extent, contributing to brackish conditions in the lagoon (Anchor QEA, Blue Coast Engineering, KPFF, 2020).

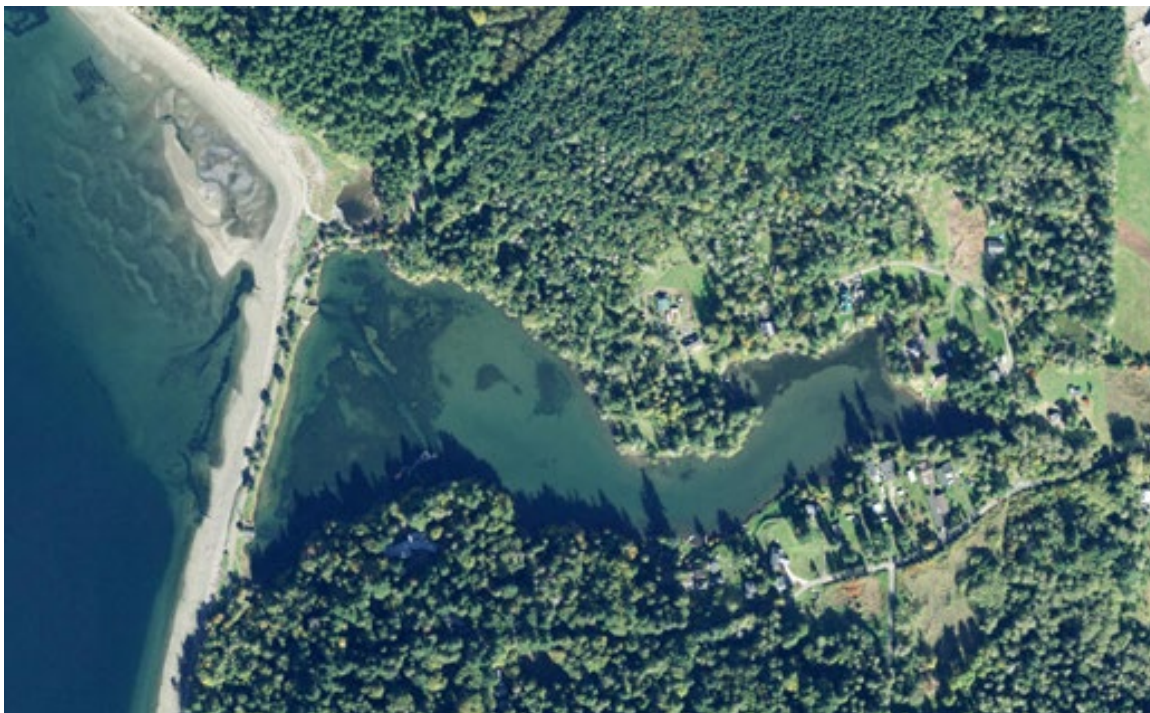
Figure 4. 2019 Aerial Photo, Whiteman Cove (Pierce County).

In current conditions, minimal tidal exchange occurs between Whiteman Cove and Case Inlet, and the potential for fish passage into Whiteman Cove is relatively low (Figure 4). A 2012 WDFW

survey found that the northern gated culvert was completely impassable. The passage utility of the southern culvert is unknown but was found to be at least somewhat obstructed in a 2000 field survey by Pierce Conservation District (Anchor QEA, Blue Coast Engineering, KPFF, 2020).

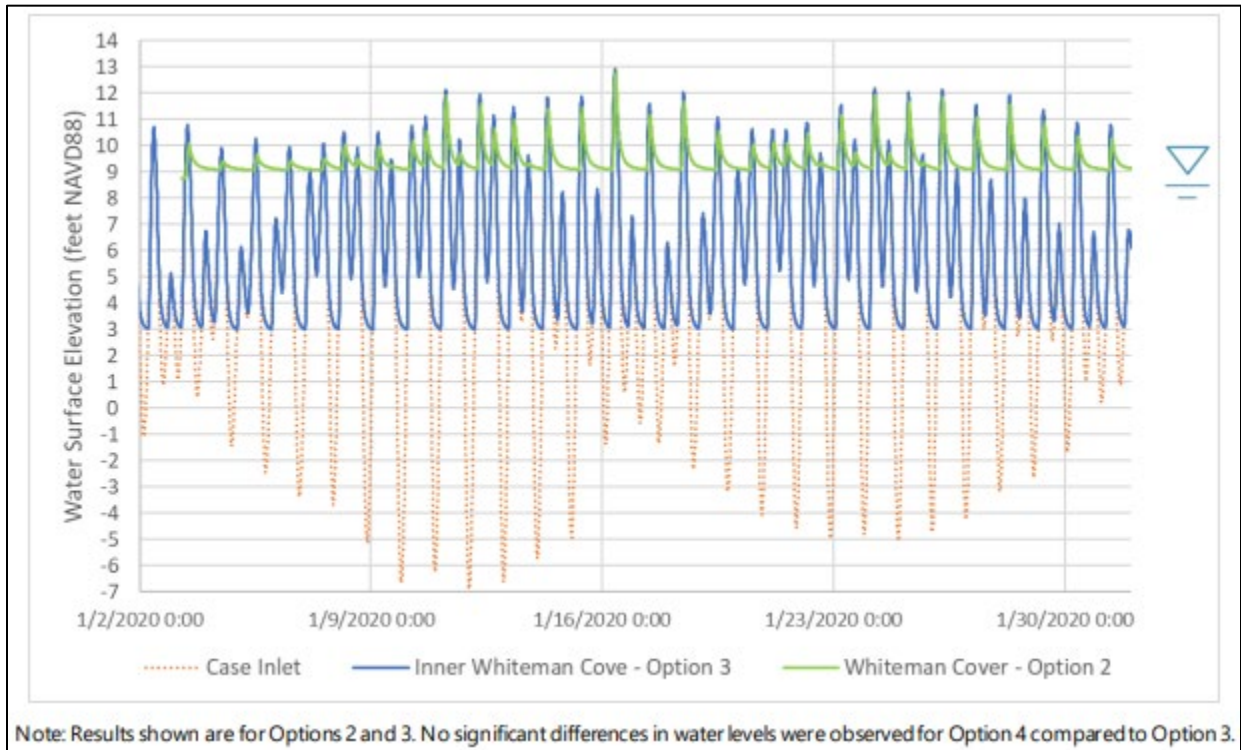
Figure 6. Predicted Water Surface Elevations in Whiteman Cove and Case Inlet (Anchor QEA, 2020).

The decrease in WSE at Whiteman Cove will have implications on the usability of the lagoon for swimming and boating. Additionally, the natural processes and decay of organic material is likely to contribute to sulfur-like odors during low tides in the lagoon. When low tides in Case Inlet drop below the proposed thalweg (lowest elevation in the restored tidal channel; 7 feet MLLW, +3 feet NAVD88) most of the lagoon shore will be dry with some ponding in areas below the thalweg elevation. Water levels are expected to be lower than 7 feet MLLW about 35 percent of the time over a typical year (Anchor QEA 2020). Figure 7 shows the areas in which there will likely be ponded water, based on the existing restoration design and recent bathymetric mapping.

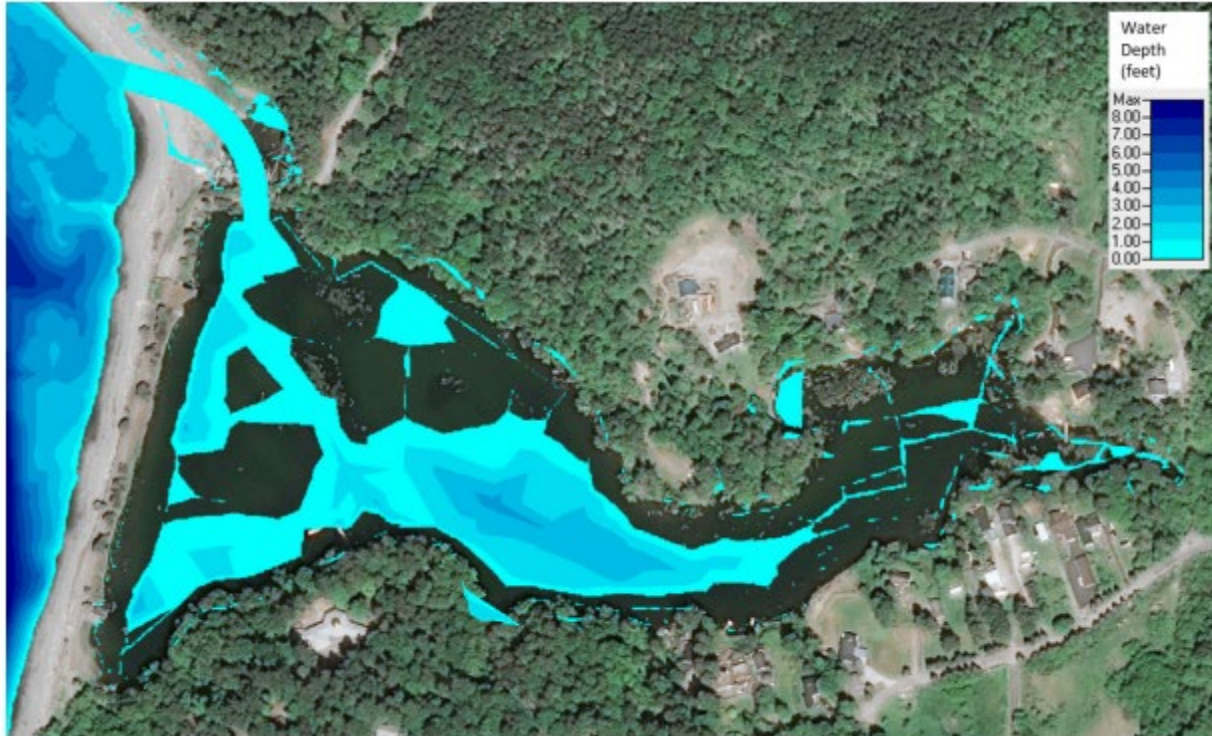
Although more limited in frequency, there will also be regular times during which the WSE in Whiteman Cove is higher than the current elevation of +13 feet MLLW (8.9 feet NAVD 88). Anchor QEA’s hydraulic modeling outputs showed that heightened WSE could range from a few inches to up to three (or more)h higher in Whiteman Cove, primarily during higher-high tides. Less frequently, but still regularly (several days per month), water surface elevations will exceed 13 feet twice per day (Anchor QEA, 2020).

Figure 7. Water Depth During Low Tide Conditions, Based on Modeling Results (from Anchor QEA 2020; Appendix A).

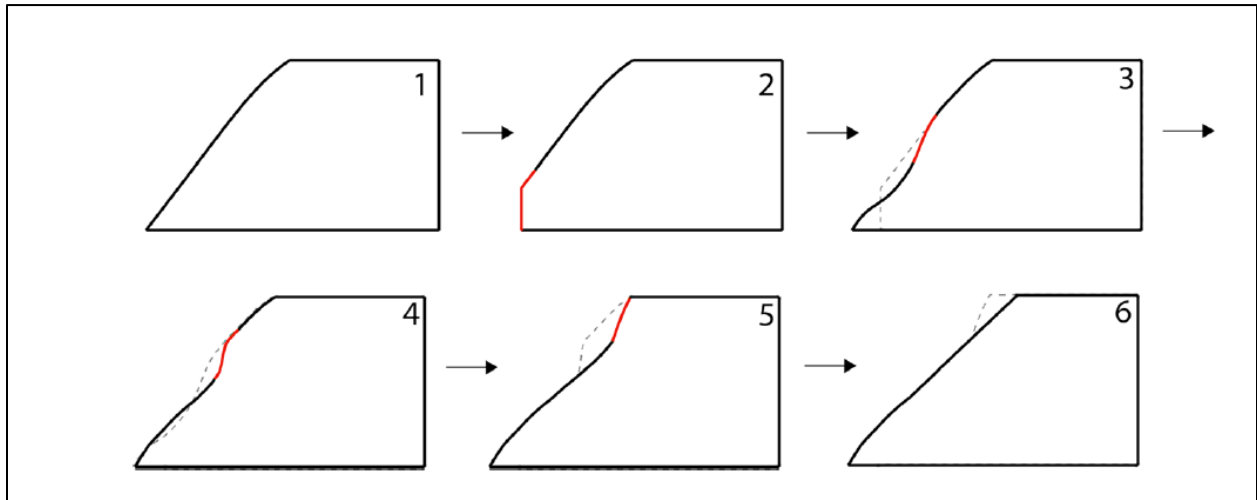
Landslides occur almost every year in the Puget Sound region during the wet season, which typically lasts from October through April. Previous research has documented a known precipitation threshold for when landslides are most likely to occur in the region. Shallow landslides most commonly occur during and following approximately 3 days of very heavy precipitation, longer periods (15 to 32 days) of substantial rainfall or some combination of the two (Scheevel et al. 2017). Coastal bluffs landslide susceptibility is greater when high water events coincide with periods of heavy precipitation. Therefore landslide activity is most likely to occur on the Camp Colman bluffs during heavy rains at Camp Colman over the 5 to 10 years that follow restoration at Whiteman Cove and more gradually in the years that follow that.

Figure 8. Stages of Bluff Recession from the Toe Up the Bluff Face Resulting from Rise in Water Level from (Krueger, 2019)

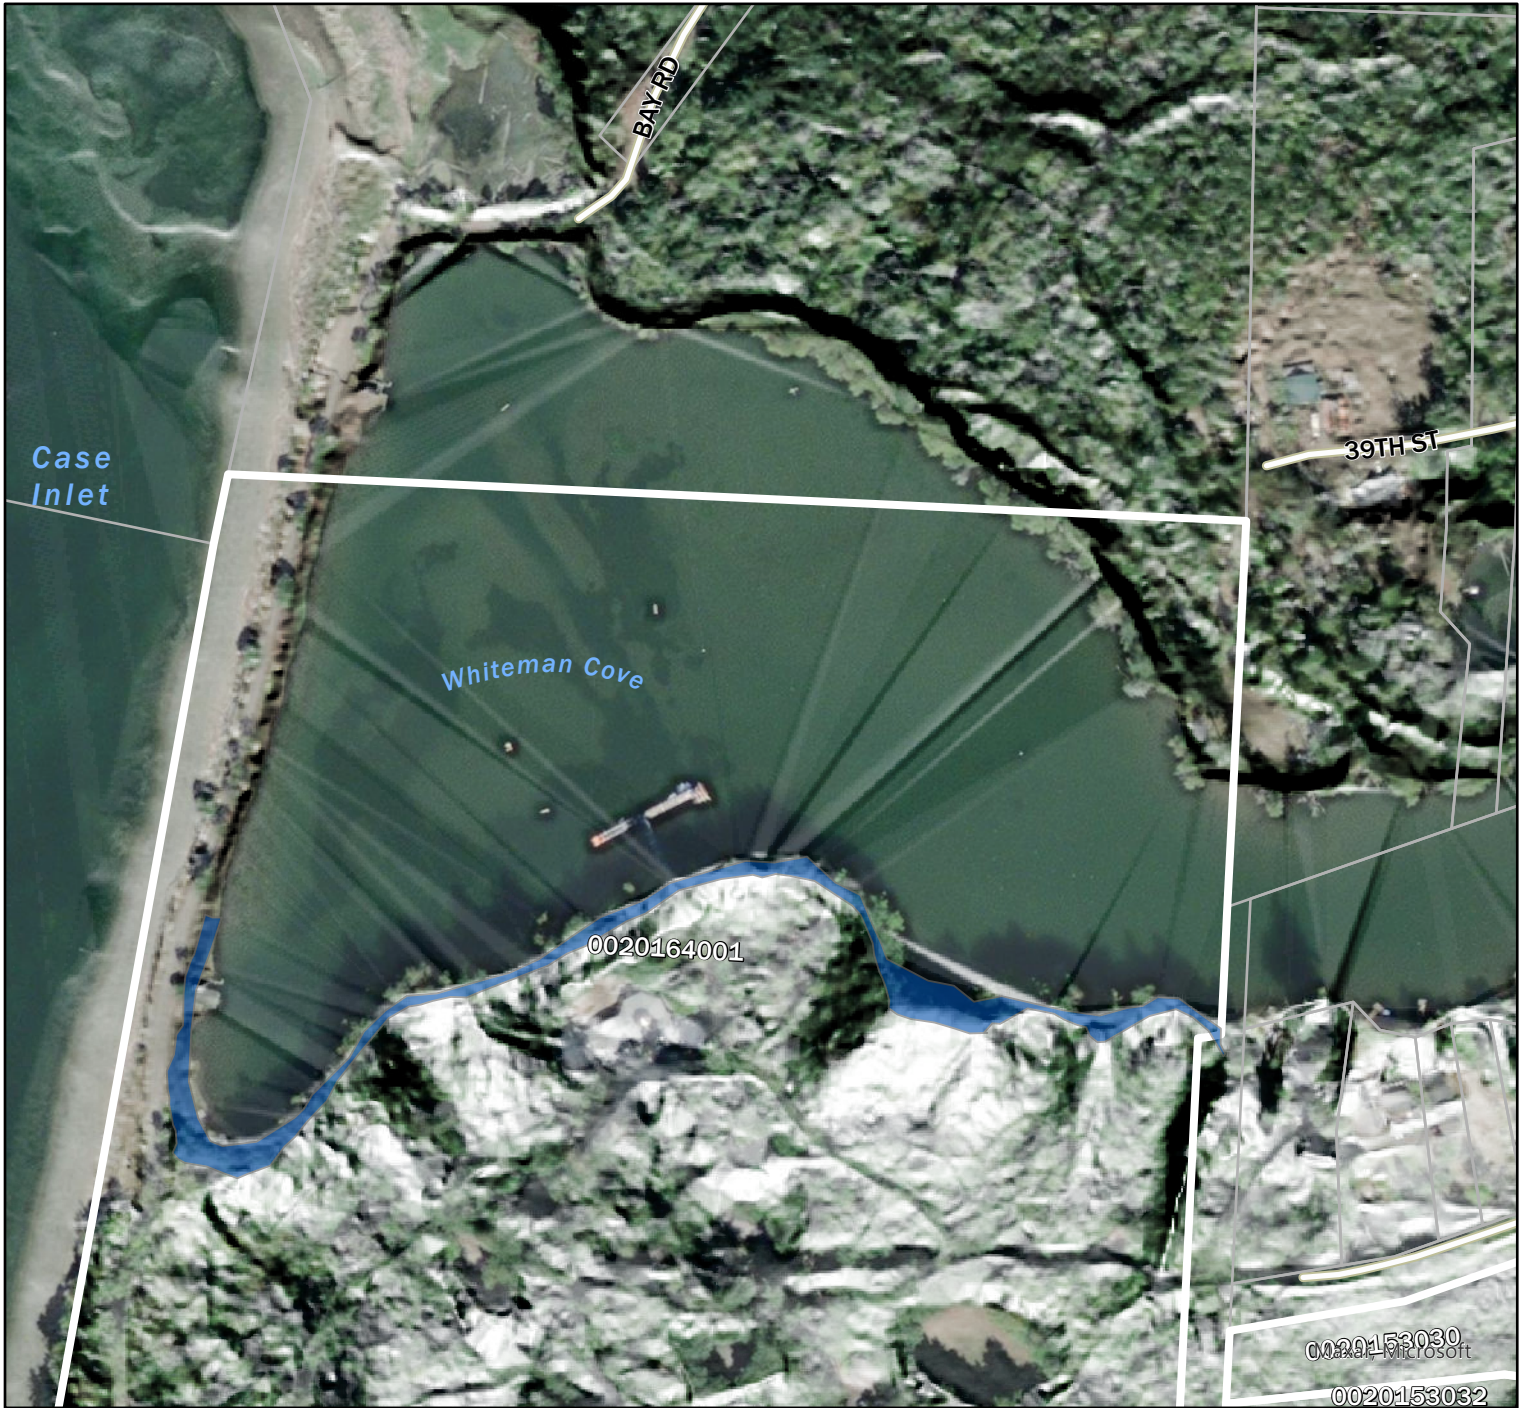
The initial impacts to Whiteman Cove include inundation and potential erosion of the coastal path that extend along the southwest shore of Whiteman Cove, the historical marine science center, and the aquatics program area. Eventually the coastal road will be breached by waves, which could contribute additional erosion of the shoreline (Figure 9).

Figure 9. Areas at Risk of Flooding Following Whiteman Cove Fish Passage Restoration.

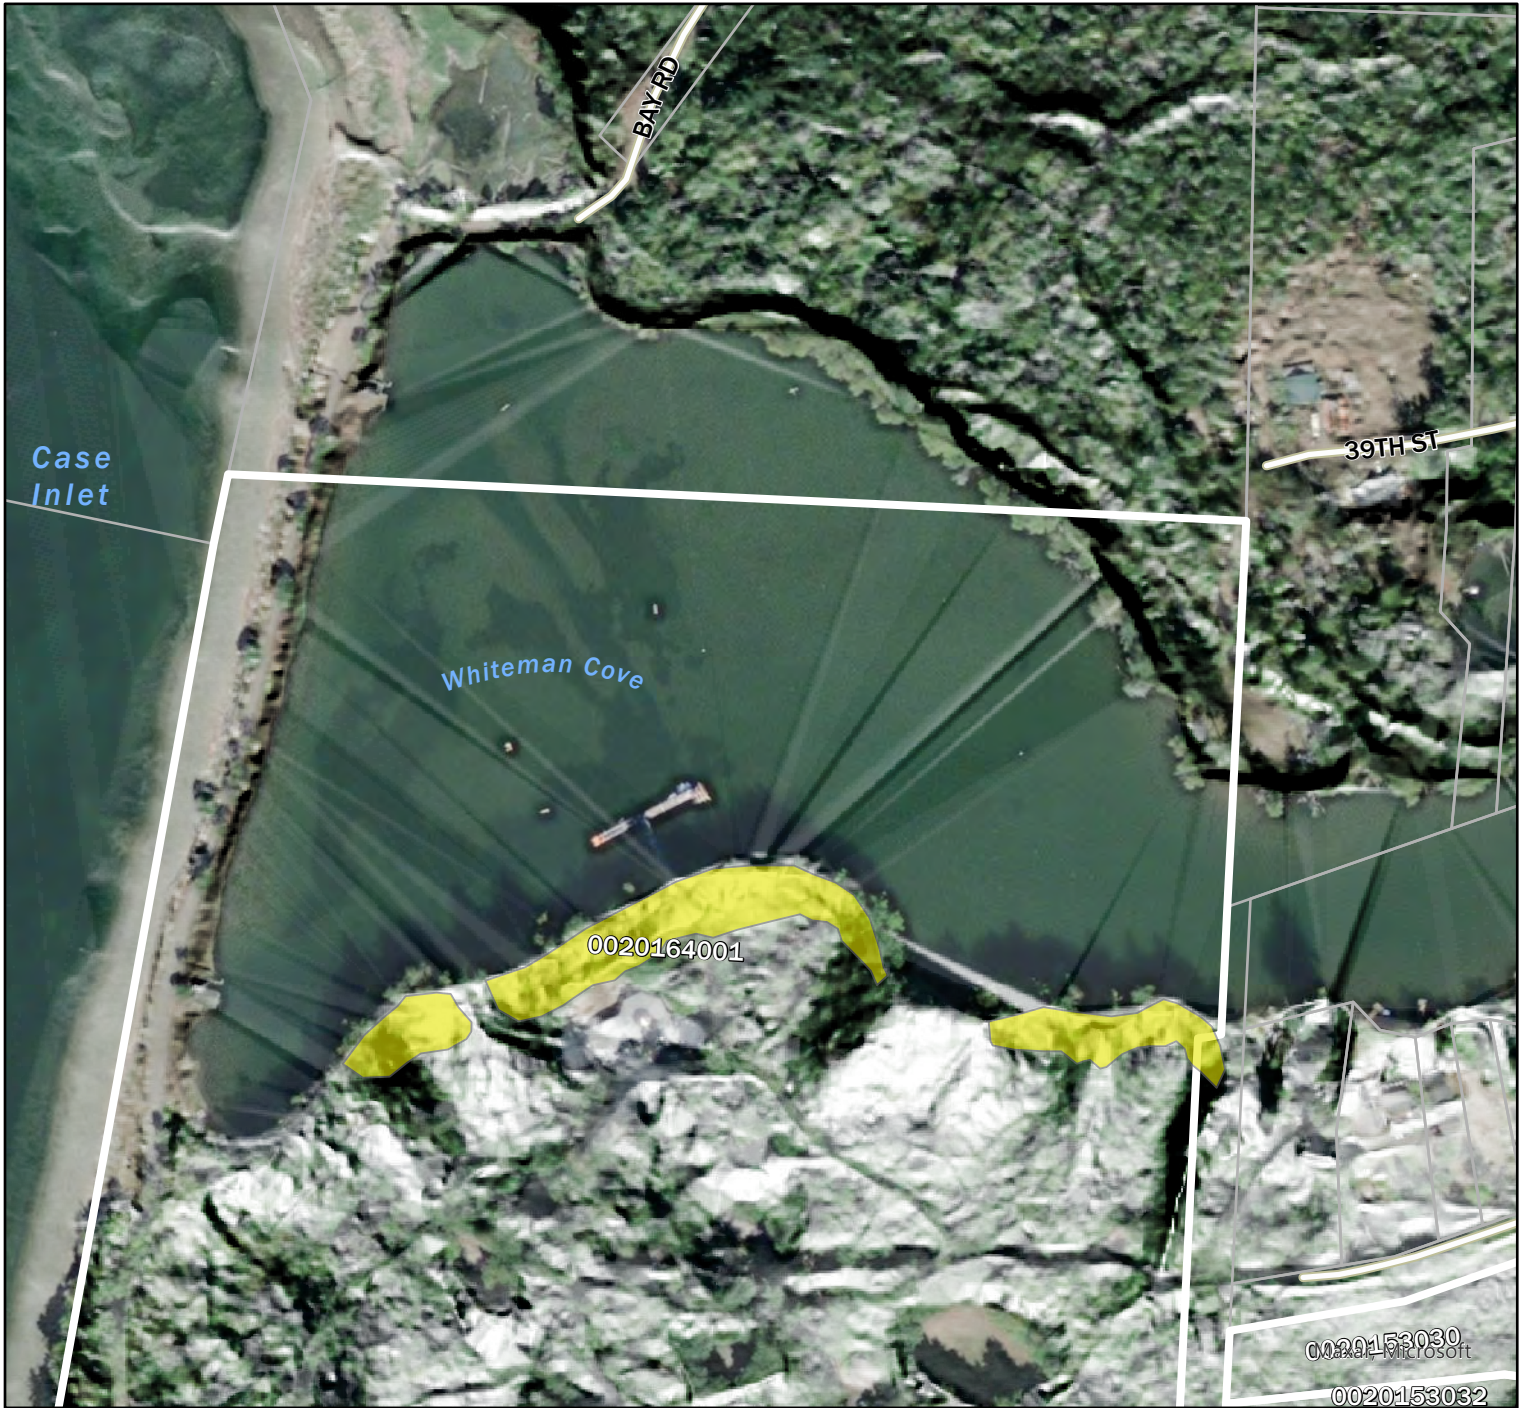
Figure 10. Areas at Risk of Erosion Following Whiteman Cove Fish Passage Restoration.

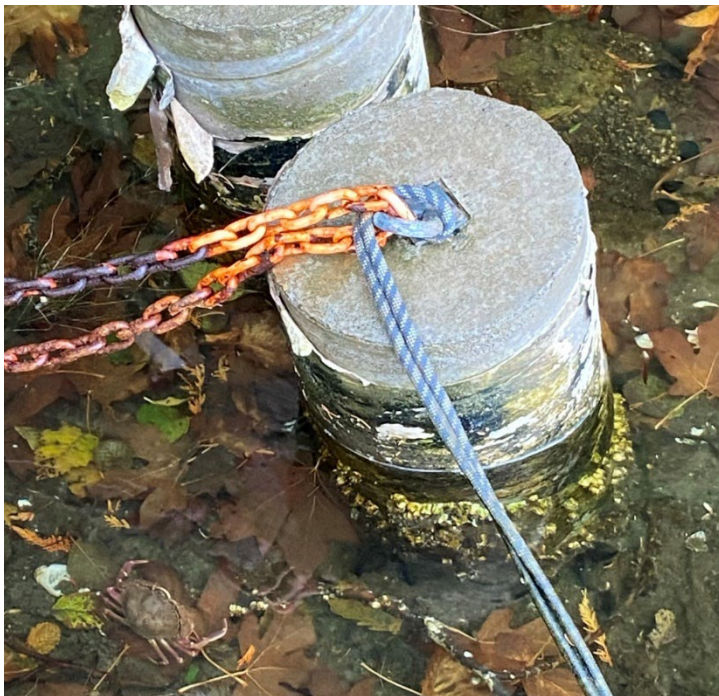
The current cement anchors are insufficient for the restored tidal environment (Figure 11). These anchors should be replaced with piles that will allow the dock and other overwater structures to rise and fall with the tide and be secured in the same position, particularly during storms. The current, fixed attachment of the dock to the shore does not allow for the rise and fall of tides expected after restoration.

Figure 11. Existing Cement Anchors for Docks in Whiteman Cove.

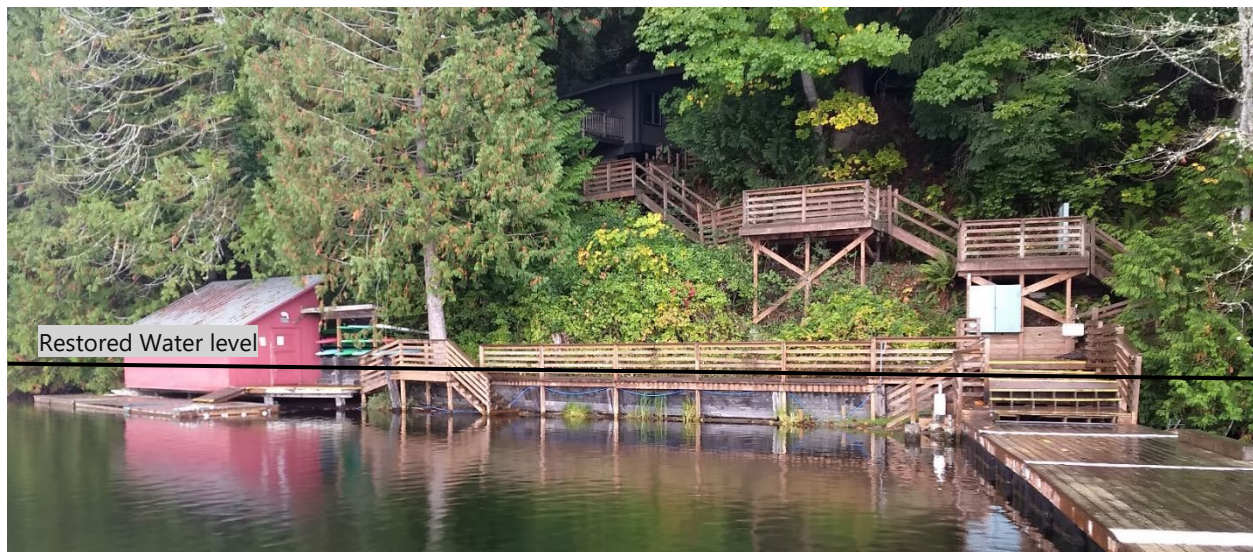
Figure 12. Gangway, Decking, and Access Stairs Will Need To Be Rebuilt to Accommodate Restored Water Level.

A new gangway will be required, secured to a deck or pier elevated above the highest tides to allow for vertical movement of the dock (Figure 12). Part of the existing decking along the access stairs could be repurposed for attaching the gangway. The access stairway to the aquatics program area should be rebuilt with its footings set at a higher elevation, and potentially repositioned to traverse a less steep area, as the bluff face is very steep and vulnerable to future erosion following restoration. The boat house located at the toe of the bluff should also be either relocated or an additional suitable location for storage should be constructed near the shoreline. Alternatively, although likely at a higher cost, a floating storage structure could be incorporated into the dock.

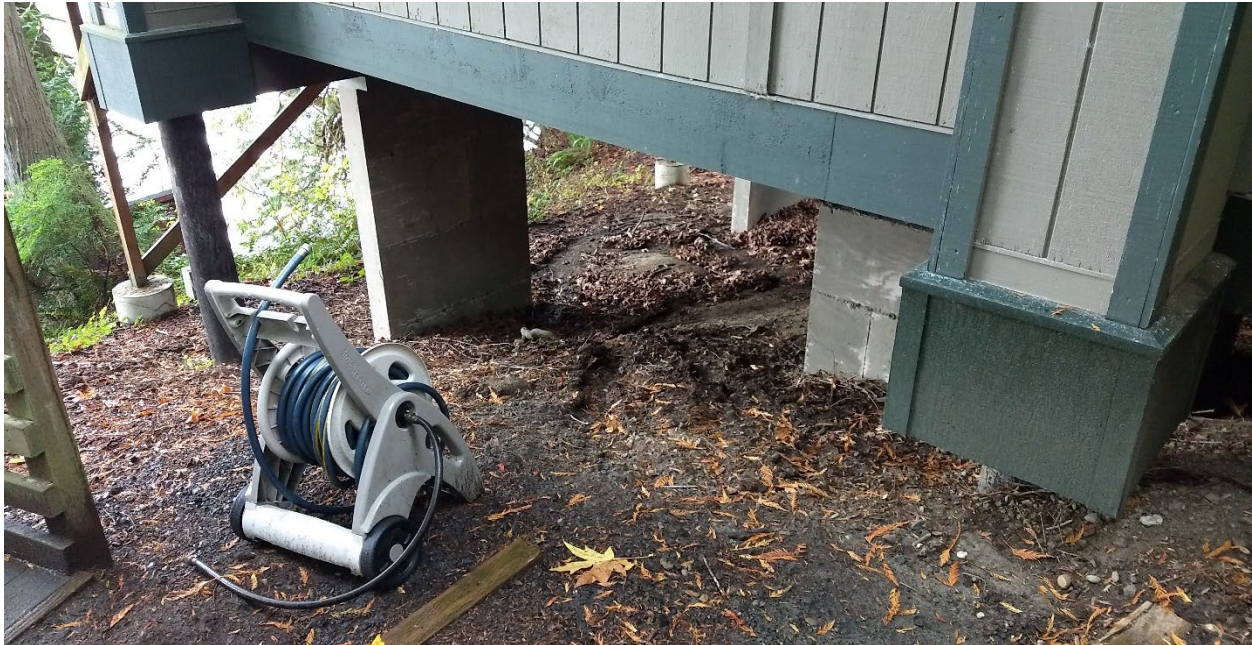
The combination of shallow groundwater at the site, documented poor permeability of the underlying geology, and presence of soils that are vulnerable to erosion suggests that improved stormwater management could benefit erosion hazard areas. Water from gutters and parking lots should not be allowed to flow directly down the bluff face but should be captured and dissipated in areas with low slopes and dense upland vegetation or tightlined directly to base of the bluff (Figure 13). Additional data on the existing topography and drainage infrastructure will be required for design of a stormwater management system.

Figure 13. Rills from stormwater Flowing Down the Uplands to the Bluff Face.

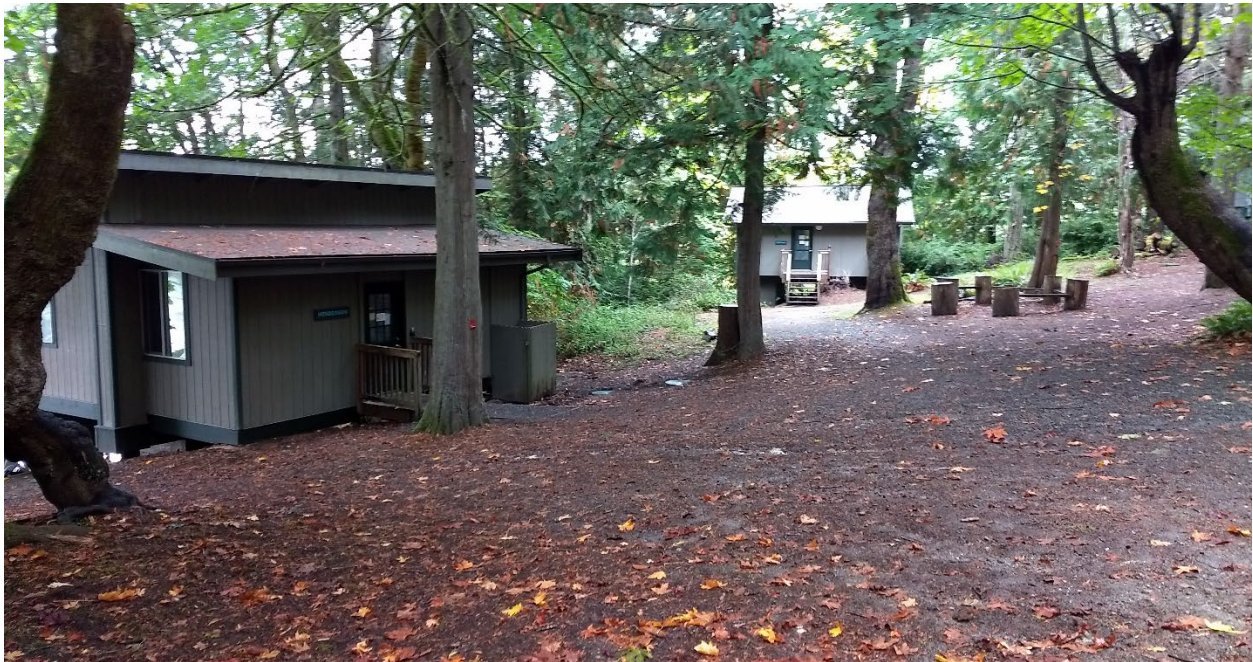
Figure 14. Henderson and Rotary Cabins in Close Proximity to the Bluff Crest.

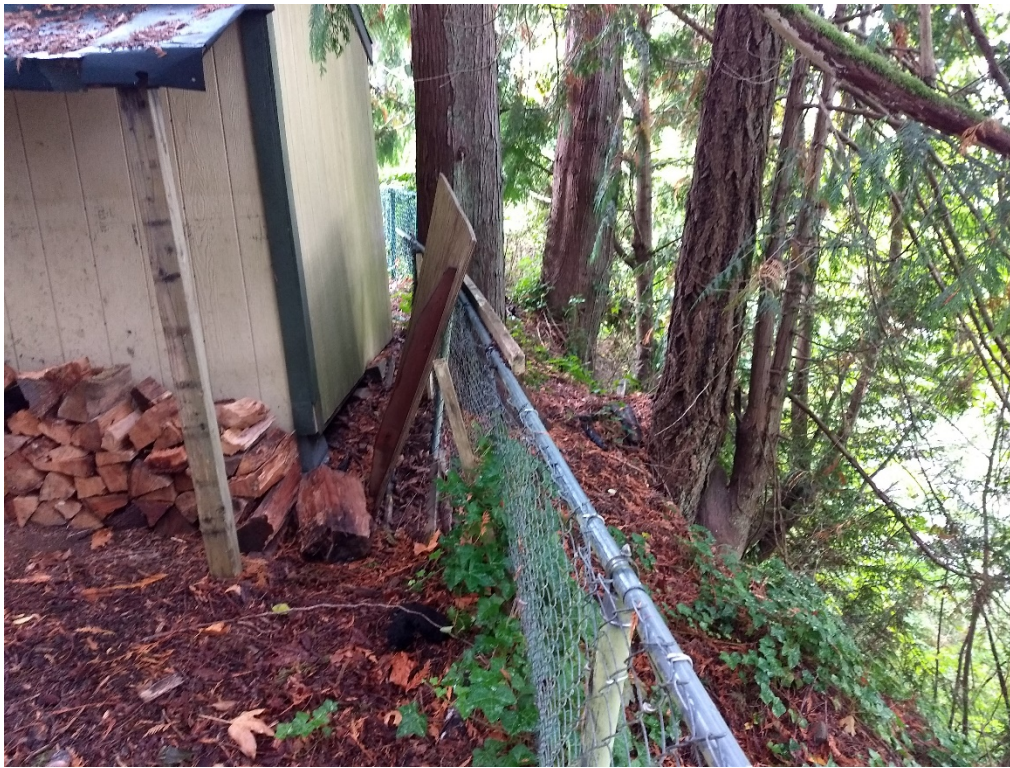
Similarly, the campfire ring and shed should be relocated to a location away from the bluff crest (Figure 15). Examination of the bluff showed obvious signs of instability just below the fence in that location, with roots exposed up to 12 inches from the edge where the bluff has been slowly eroding out from under the trees.

Figure 15. Close Proximity of Storage Shed to Bluff Crest.
