Consolidated Forensic Laboratory Report

December 2021

Washington State Patrol Forensics Division - Facilities Master Plan

4.0 Existing Conditions

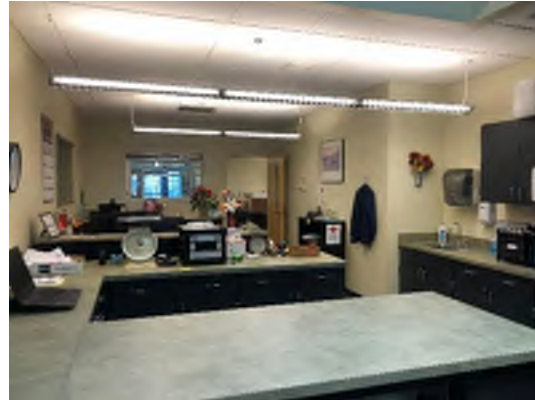
Evidence Processing

Evidence storage space in the lab areas is overcrowded and, in some cases, has been repurposed to support other uses that could not be accommodated in the lab areas. (see lab observations below)

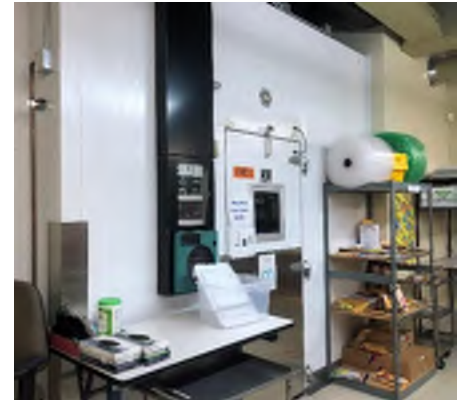
Cold Storage Evidence

- *Evidence*
The intake is provided with a separate, secure vestibule and lobby. There is an identified evidence viewing room that can be accessed from the secure side as well as the lobby. The main evidence storage area generally accommodates current need but has little room for future expansion. Future growth anticipates adding one property evidence custodian. This will require reconfiguration to accommodate administrative space for this position. As the administrative operation reduces paper use, converting the current records room for use in evidence administration and storage could accommodate anticipated growth.

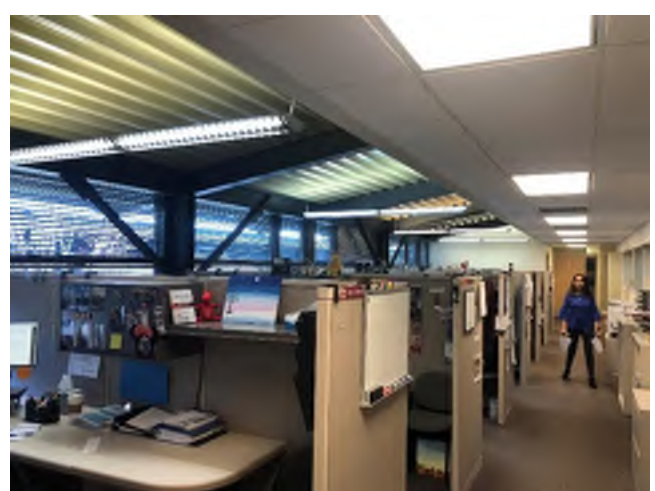
Typical open office workspaces

- *Insufficient Personnel Support Space*
 With staffing greater than originally planned, the break room is undersized. To accommodate the need, the original library space has been repurposed into a quiet break room and the library functions dispersed into the open office areas. Lockers, showers, and toilets appear adequate for current and projected staffing.

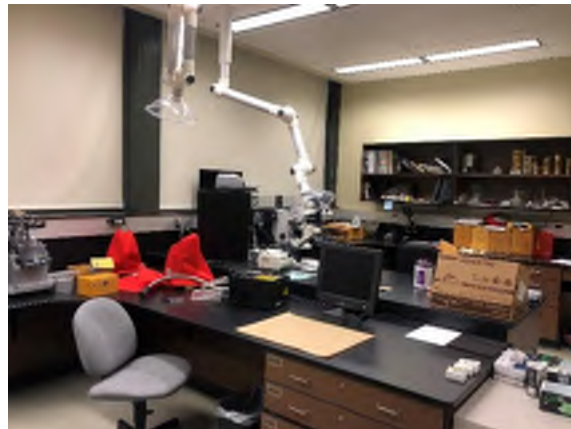
MA Lab

- *Microanalysis/Trace Lab*
 There are four “U” shaped workstations in the lab serving two scientists. Located in the southern part of the east wing, this space is adequate for current and projected use.

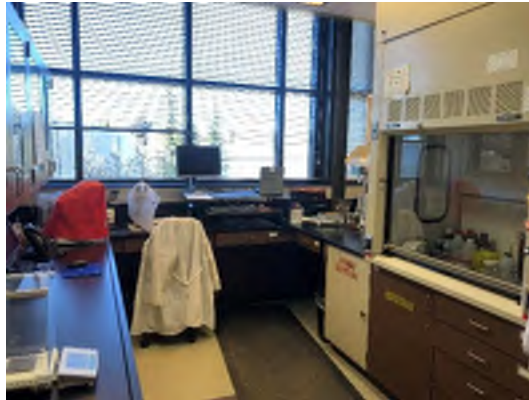
Chemistry Lab

- *Chemistry Lab*
 Located in the west wing of the lab, the Chemistry section provides 10 lab stations in this lab area currently serving five scientists, four in the MA sections and one in QD section. This meets current need. Near term plans are to add two scientists in the MA Section and another one in QD. This can be accommodated in the existing lab space.

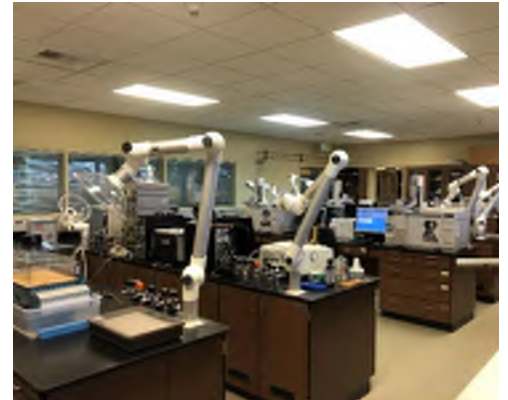
Instrument Lab

The adjacent instrument room functions for current need but has no capability for increasing equipment in support of staffing growth.

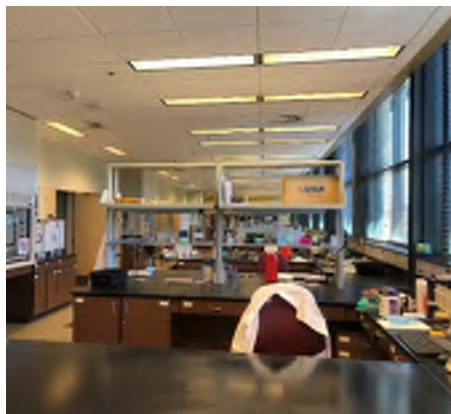
DNA Lab

Near-term growth includes adding two more DNA scientists in this lab. To accommodate this growth and to provide adequate lab workstations for 14 scientists, additional lab stations will be needed.

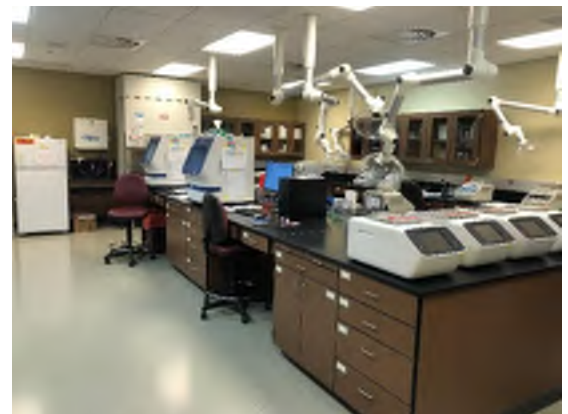
Post-Amplification Lab

The adjacent Extraction, PCR Set-Up, and Post-Amplification labs have been adequate for current use; however, fitting the amount of instrumentation in the current benching has been difficult. In the future, it is anticipated that new instrumentation will be smaller in size and will mostly be accommodated in the current space. If adequate administrative space is provided, the spaces that were intended to be exam rooms that have been repurposed for offices could be used to support DNA sample prep and processing.

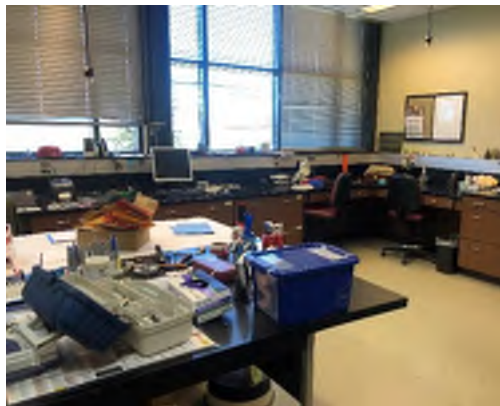
- Latent Prints Lab*
 This lab was constructed in 2012 in a space that was originally intended as a toxicology lab. It has two workstations and an adjacent evidence/photo room serving three scientists. Originally designed with two additional workstations, it was reduced in size due to budget constraints. To accommodate all current staff without “sharing”, one additional lab station is required. Long-term growth would require a total of four lab stations dedicated to this function.
- Firearms Lab*
 Located at the north tip of the west wing, this lab houses two workstations serving three scientists. Near term growth anticipates adding an additional FA scientist. The scientists use the lab space for both casework and administrative functions. It is crowded and needs to be expanded/modified and separate administrative space provided for each scientist.

Firearms Lab with office workspace on lab top

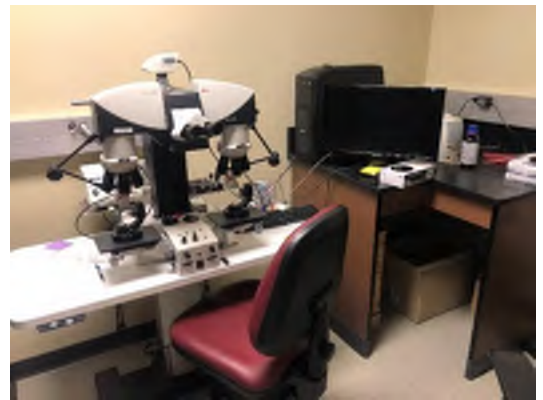
The NIBIN lab is planned to be repurposed into a supervisor’s office. The microscope lab was designed for one scope station, but currently houses two with a third station planned. This expansion would either occur into the workshop space or be relocated into the existing exam room. The workshop and the Caswell range appear adequate for current and future growth.

PFA Microscope Lab with 2nd scope in corridor

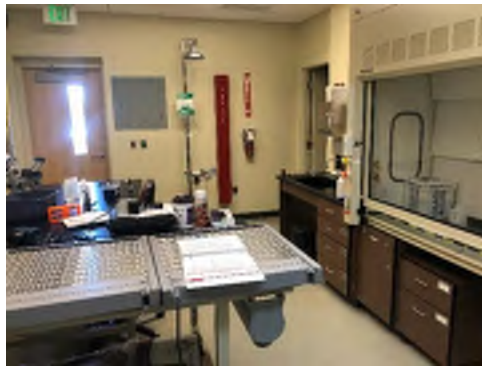
CSR Lab

- *Crime Scene Response (CSR)*
 The CDR section was not initially programmed as a housed function when the building was designed. It currently occupies three office spaces housing five scientists. What was initially designed an Evidence Lab has been repurposed to serve as a CSR Exam Lab. As the CRST has a mobile response vehicle that needs to be housed in an environmentally controlled space, the vehicle evidence bay has been used.

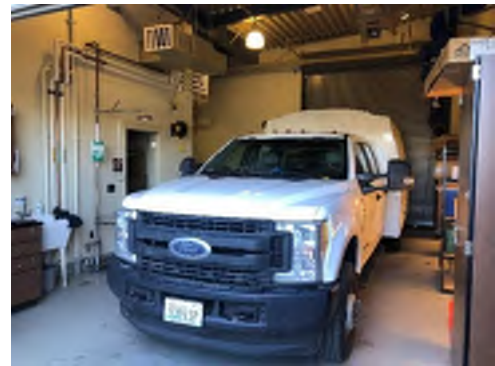
Vehicle Evidence Bay repurposed to house CSR Vehicle

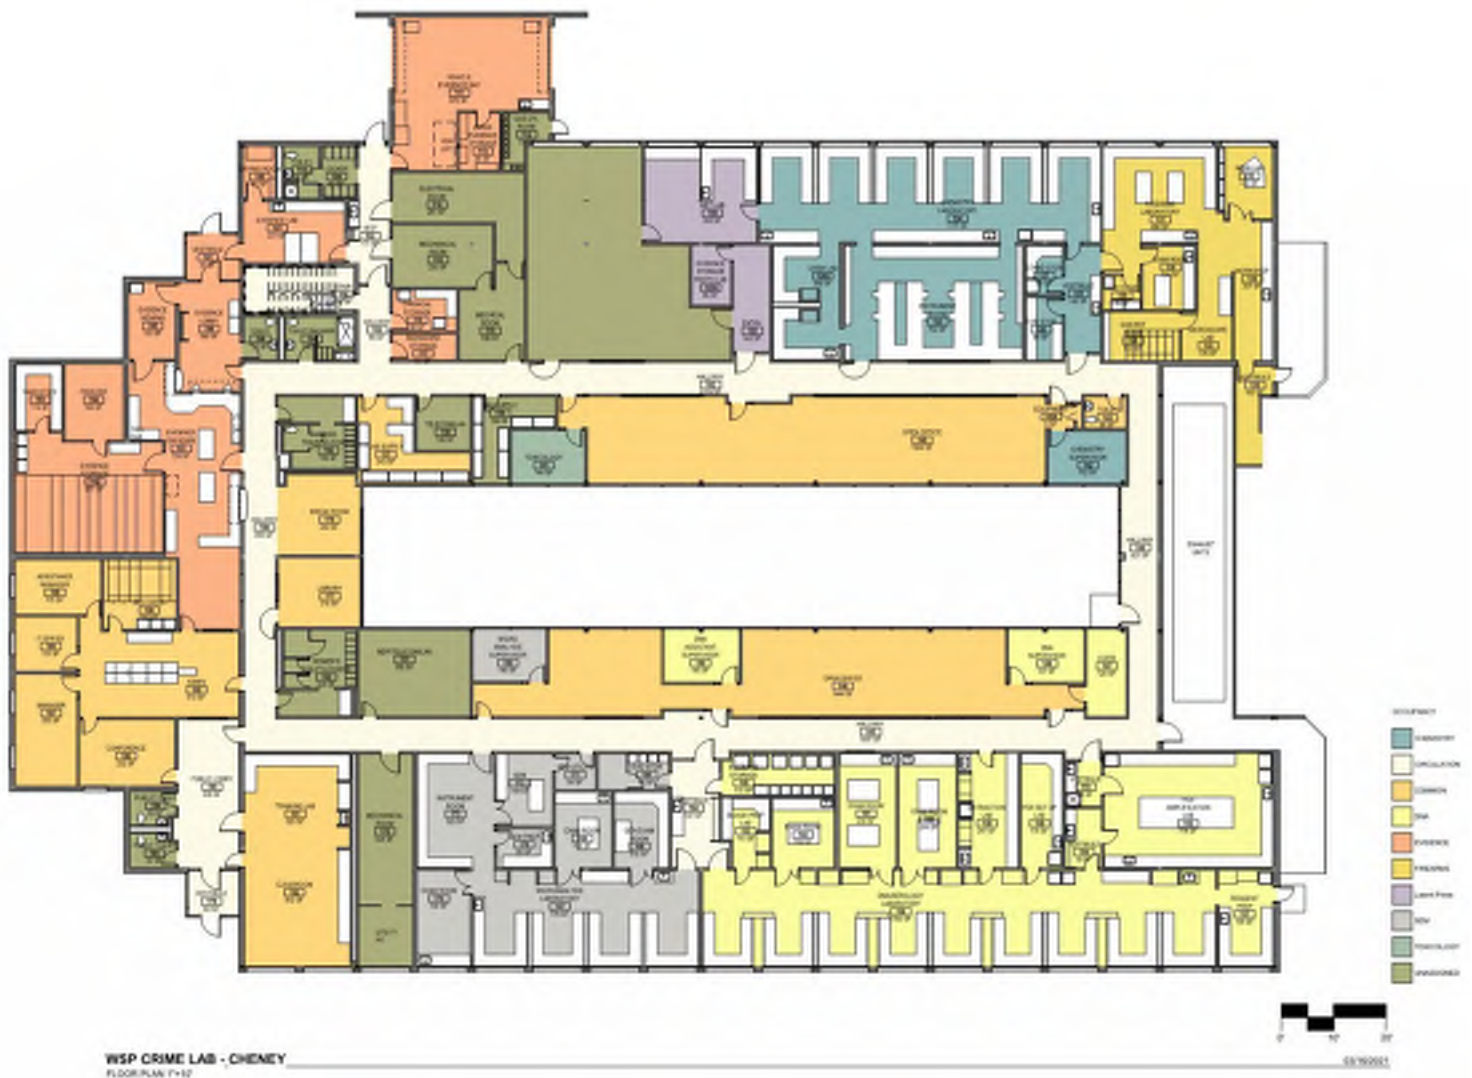
Existing Floor Plan/Space Assignment

<i>Program/Space</i>	<i>Existing Area (36 FTE)</i>	<i>Notes</i>	<i>Projected Area (44 FTE)</i>
Trace /Exam Room	323		323
Exam Room	190		190
Exam Room	158		158
MA/Trace Office	152	Repurposed Exam Room	152
SEM Room	150		150
SEM Prep	80		80
SEM Utility	54		54
DNA	6,128		10,244
DNA Supervisor Office	147		147
DNA Supervisor Office	145		145
DNA Manager Office	126		126
Open Office	1,444	Current 9 workstations. Future 14 workstations	3,640
Lab Vestibules	140	3 each. 1 to lab and 2 in/out Post Amp lab	200
Evidence Storage	265		265
Lab Prep	110		110
Lab Office	160	Repurposed Exam Room. Future exam room	160
Exam Room	240		240
Exam Room	240		240
DNA Lab	1,780	9 existing Lab stations - 14 future	3,640
Extraction	247		247
PCR-Up Lab	175		175
PCR Amplification Lab	714		714
Reagent Prep	195	Functions also as an office	195
NET ASSIGNABLE	20,027		29,644
Unassigned	14,073		14,617
General Storage	484	Includes janitor/supply, chem/biohazard	484

Circulation	3,696	Includes vestibules and lobby	4,446
Toilets	850	Includes lockers	850
Mechanical/Electrical/Systems	4,094	Includes 2,500-sf in attic but not 1,000-sf ground-mounted units at the south	4,094
Shelled Space	1,160		-
Walls and Structure	4,273		4,742
TOTAL GROSS	34,100		44,260

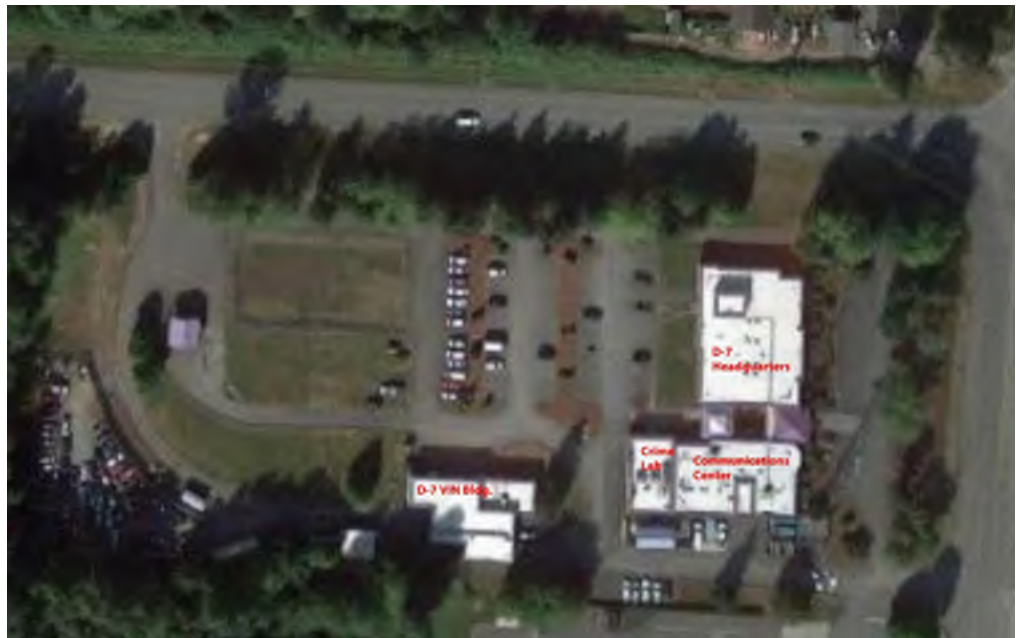
Marysville Site

The only issues identified at the site relate to utilities. The existing sewer system is at its maximum capacity. Domestic water availability is also a potential issue. Until a recent change of source to the tribal water utility, water had been sourced from an on-site well. The amount of sand has caused problems with plumbing fixtures and fire protection devices in the building. This aspect does not impact laboratory functions as DI water is sourced in containers.

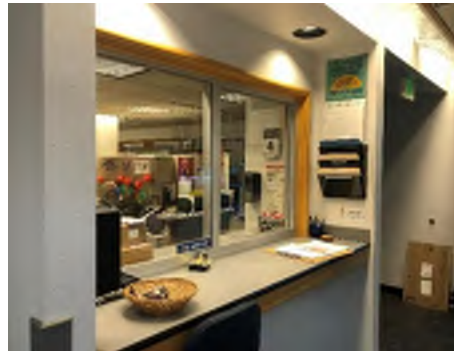
Evidence Receiving Lobby

- *Public Access*
There is little or no public access to the lab except for served agencies and delivery services dropping off evidence parcels.
- *Evidence*
The intake is provided with a secure vestibule/corridor lobby. There is no room provided for evidence viewing. The main evidence storage area does not accommodate current need. There are two commercial-grade (food service) freezers in the evidence room and there is insufficient room to fully open the door. The room was not designed for the added heat generated by this equipment and the packaged AC unit barely provides supplemental cooling to off-set heat gain. There is a smaller bio-evidence storage room that has locked cabinets and a residential-grade side-by-side refrigerator/freezer. It is inadequate size for current needs. There is no capability for future expansion.

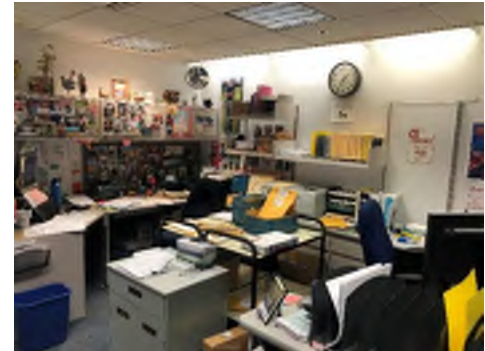
Evidence Custodians do all processing in their administrative space

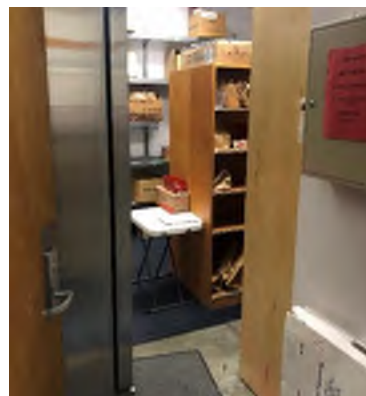
Evidence room – Note Freezer in way of door swing

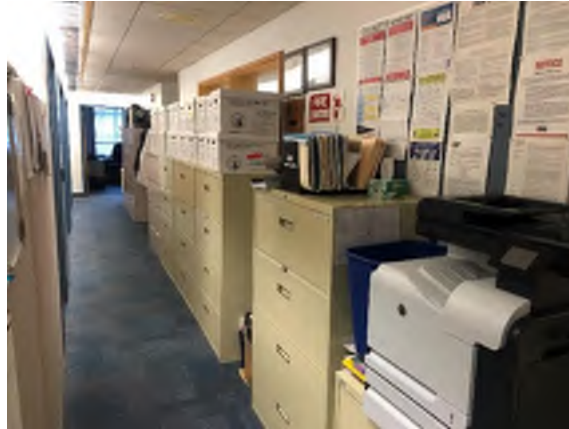
Files placed in corridor

There is a noted lack of storage for records, case files, and material/supplies. Wherever staff can find room, they use it for storage. File cabinets are placed in corridors, boxed supplies are stored over equipment or in knee spaces in the lower cabinetry. To address this need, there is an exterior secure steel container used to store one year of case files.

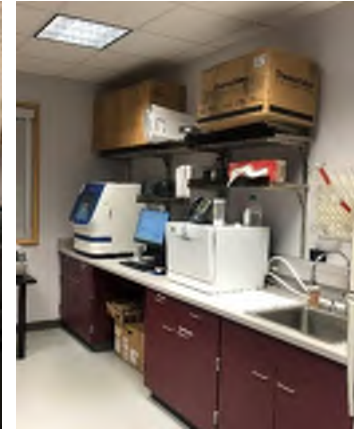
Note supplies stored over equipment and in lower casework knee space

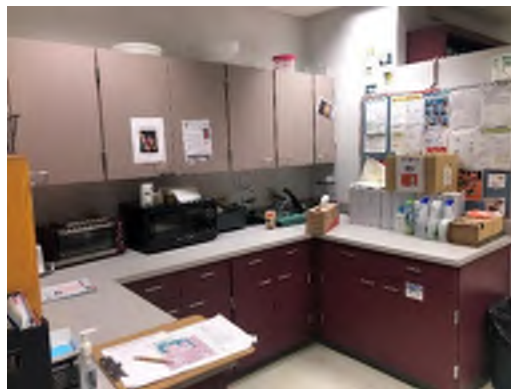
With staffing greater than originally planned, there is no space provided for non-work personnel support. There is no break/lunch space. The only accommodation is a small area of benchtop where a coffee pot and microwave are located. There is no provision for personnel lockers. The staff need to use the District facilities for showers and toilets.

The only accommodation for a staff break area is a microwave and toaster oven on a work counter

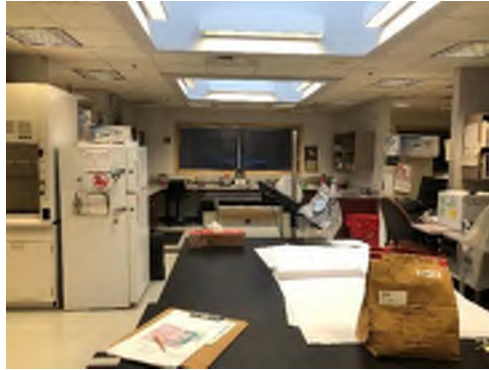
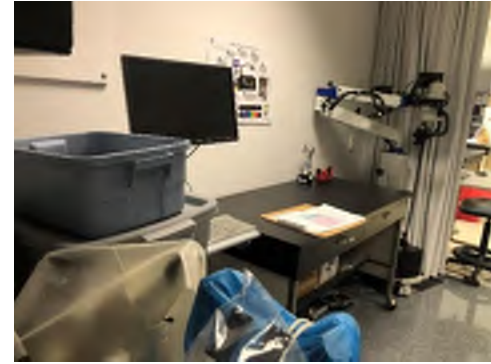
Shared exam tables on the open lab area.

There are no dedicated exam rooms. Examination of evidence takes place on common worktables in the open lab area. This is a severe impact on efficiency of workflow as any investigation/processing has to be scheduled for a single work time as it is impossible to secure in place if the task takes longer than a single shift. This also contributes to possible cross contamination.

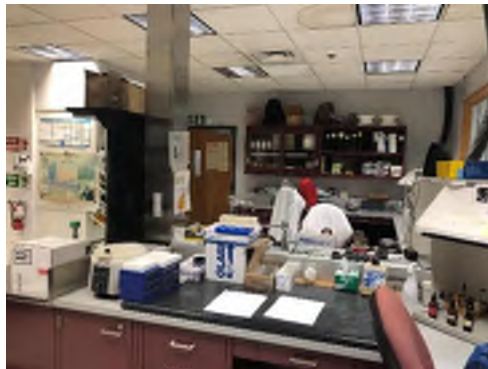
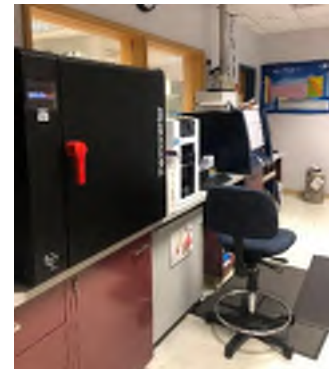
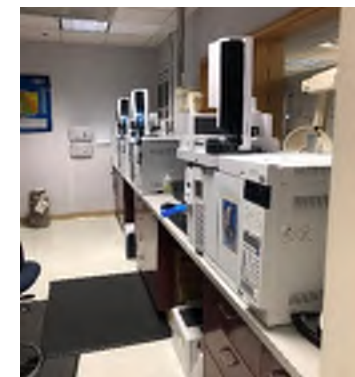
Chemistry Lab

The adjacent instrument room is cramped and overcrowded. It has no capability for increasing equipment in support of staffing growth.

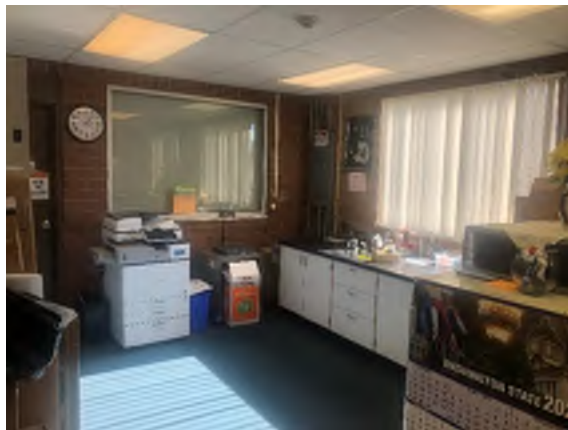
Evidence processing in administrative space

- *Public Access*
There is little or no public access to the lab except for served agencies and delivery services dropping off evidence parcels.
- *Evidence*
The intake is provided with a secure vestibule with a pass window that does not appear to be used. There is administrative space for two property and evidence custodians. Evidence processing occurs in the administrative area. There is no room provided for evidence viewing. The main evidence storage area is provided with some interior caging. It generally appears to accommodate current need. There is a smaller evidence storage room off the lobby that has locked cabinets and appears to be adequate size for current needs. There is no capability for future expansion.

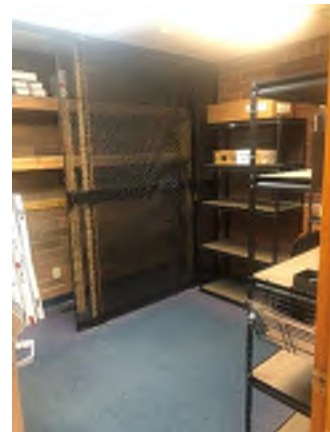
Small evidence storage off lobby

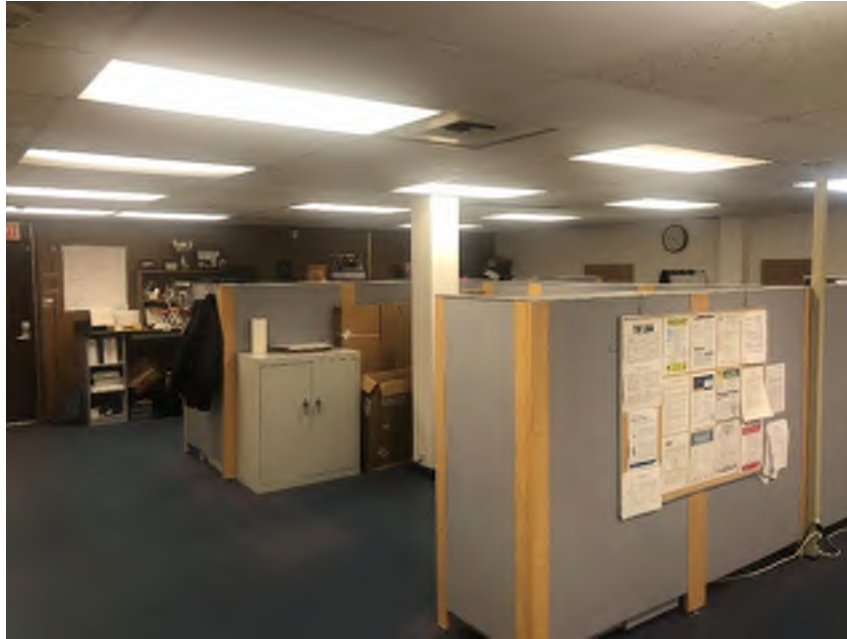
Open office workspaces

Administrative space is provided for seven Forensic Scientists in two open office spaces. There are eight workstations provided. The administrative space is interior to the building and has no access to daylighting. Office support functions such as files, storage, copiers, etc. is placed around the administrative area and in the circulation space.

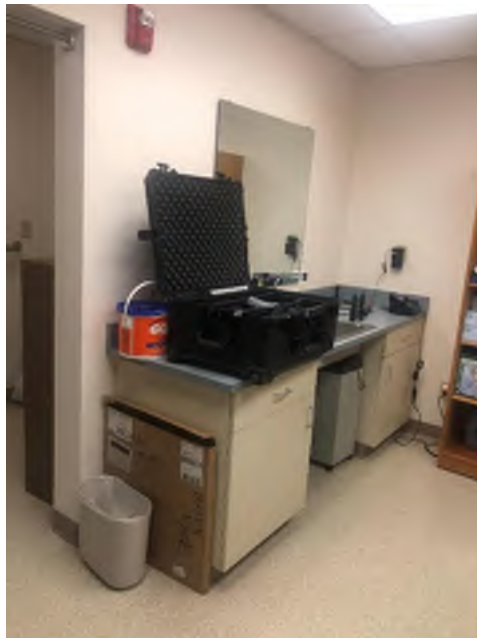
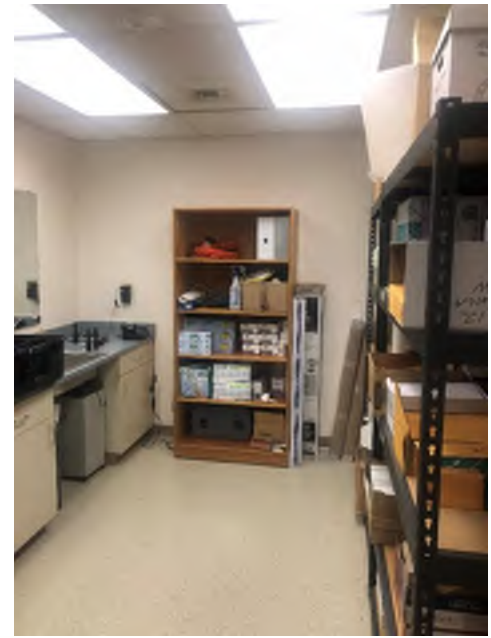
General Storage

- *Storage*
A shower and sink room located off one of the Photo Labs has been repurposed to serve as general lab storage. The space seems adequate; however, having to access this from the photo lab is an operational impact. There is another small storage room adjacent to the toilet areas.

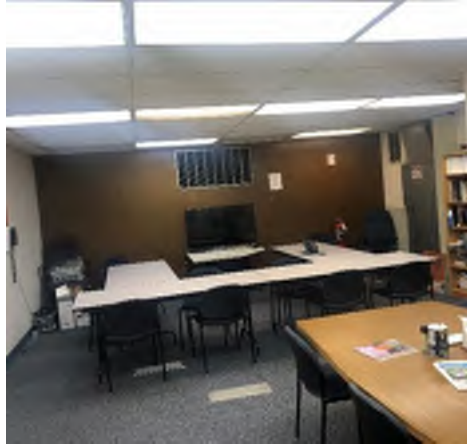
Classroom

The classroom/break lab is serviceable for the assigned staff. The lack of daylight and vestiges of exposed HVAC in the room contributes to a worn and negative environment.

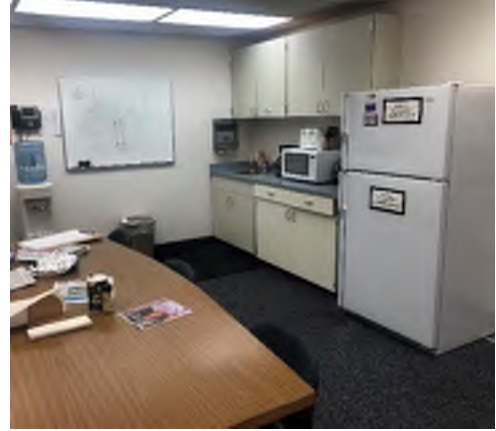
Lunch/Break area within classroom space

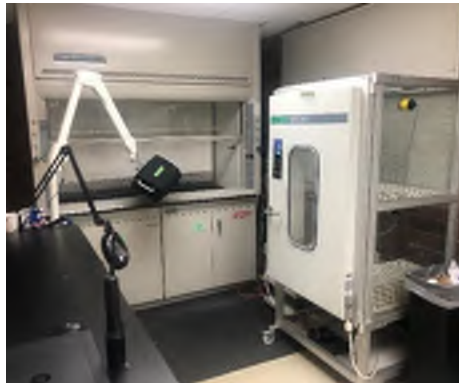
Lab #1 Fume hood and MCV Cabinet

There are two dedicated lab spaces, each provided with one fume hood. Lab-2 has a utility sink. Equipment (fuming cabinets, NINcha chamber, etc.) are located on the perimeter either freestanding or on casework or carts. The storage capacity in the labs appears adequate. There are two dedicated photo/alternative light exam rooms. These appear to meet current needs. There are no vestibules at Lab entrances.

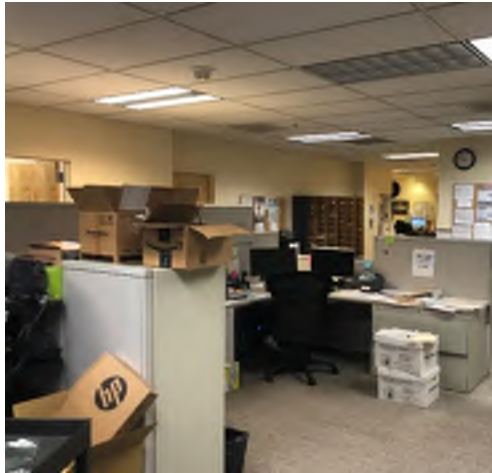
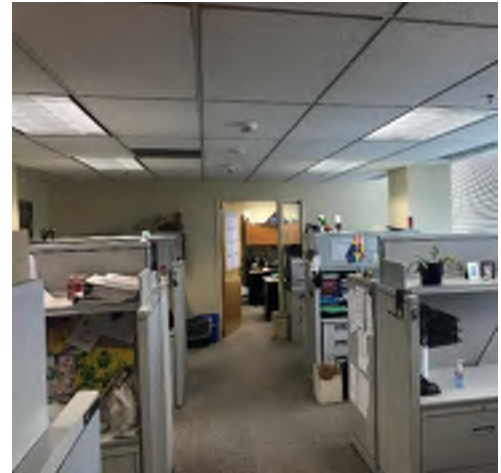
Typical open office workspaces

The open office area in the Firearms Section was originally designed to support three staff but currently houses five. Access to adequate administrative space for scientists in the Toxicology section has also been an impactful issue. Initially planned for 25-scientists, the toxicology office space now supports 36 FTEs in this same space. This has resulted in both administrative and scientific personnel doubling up on office space. This situation will be partially addressed with the planned temporary toxicology lab in Federal Way.

In general, offices are cramped and congested and there is no room to accommodate any program or personnel growth.

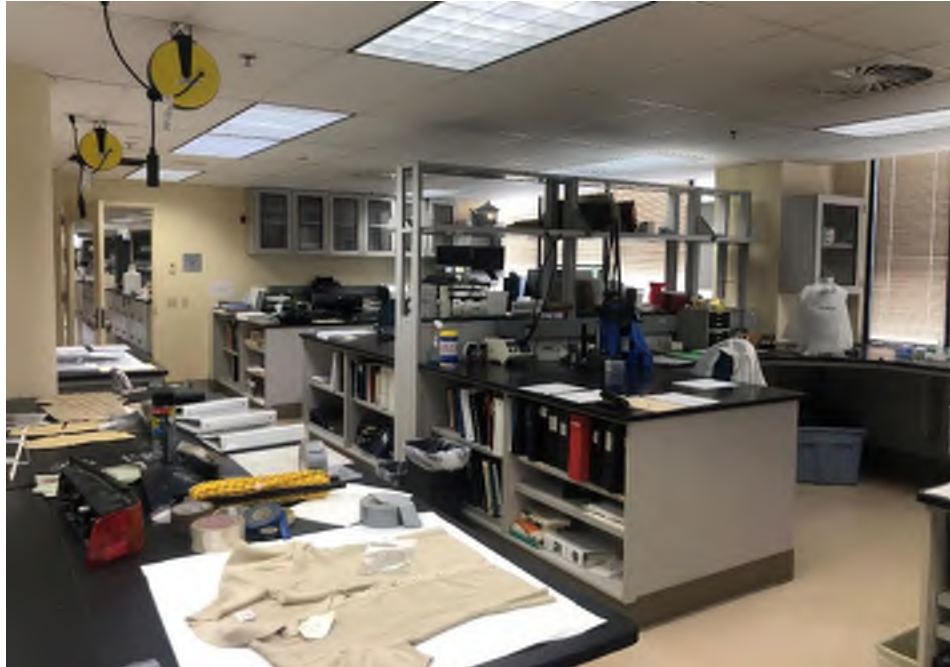
Located in the southeast corner of floor three, MA Lab entrance corridor has a wash station but is not configured as a controlled vestibule. There are six “U” shaped workstations in the lab. Two exam rooms, a SEM analysis room, a secure reference storage and small evidence room are included. This space appears adequate for current and projected use.

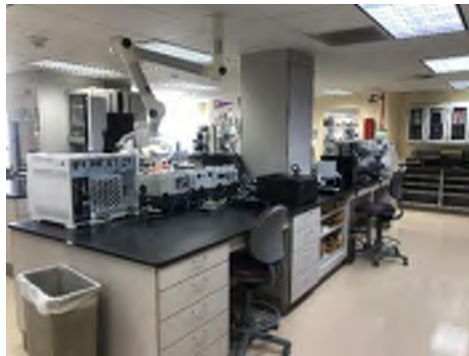
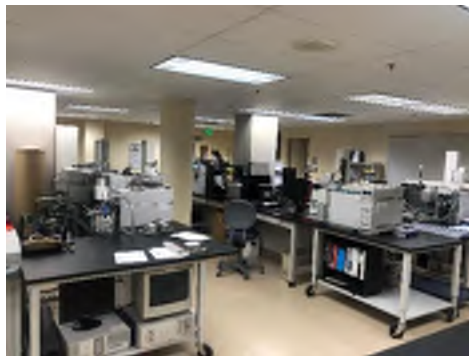
Chemistry Lab

- *Chemistry Lab*
Located adjacent to the MA Lab, the Chemistry section provides 10 lab stations.
This meets current need.

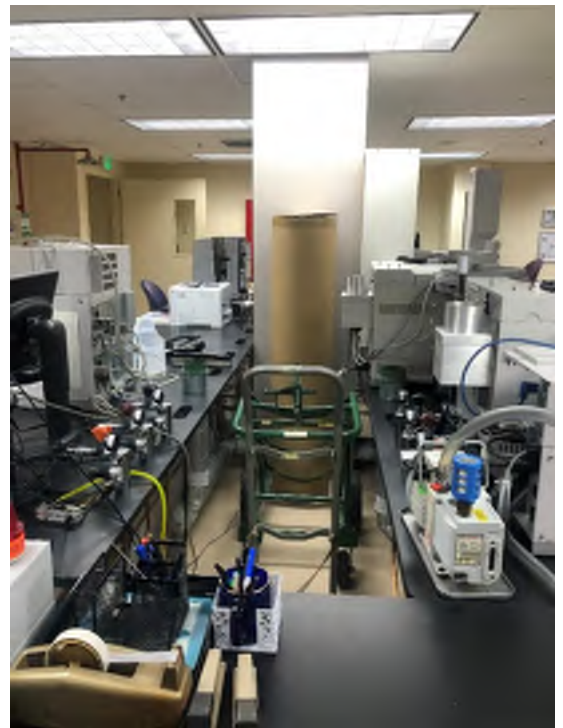
MA/Chem Instrument Room

The adjacent instrument room functions for current need but has no capability for increasing equipment in support of staffing growth.

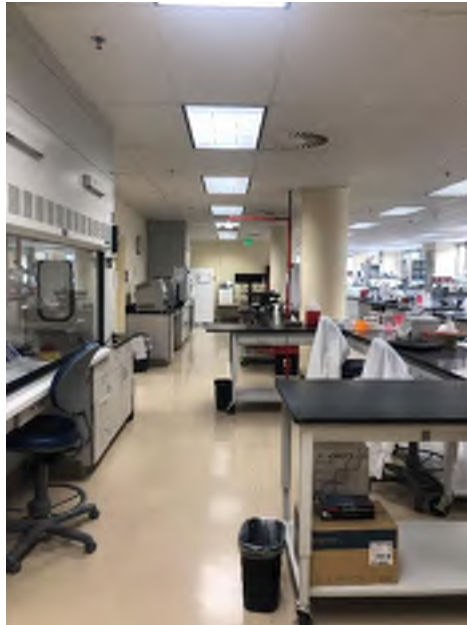
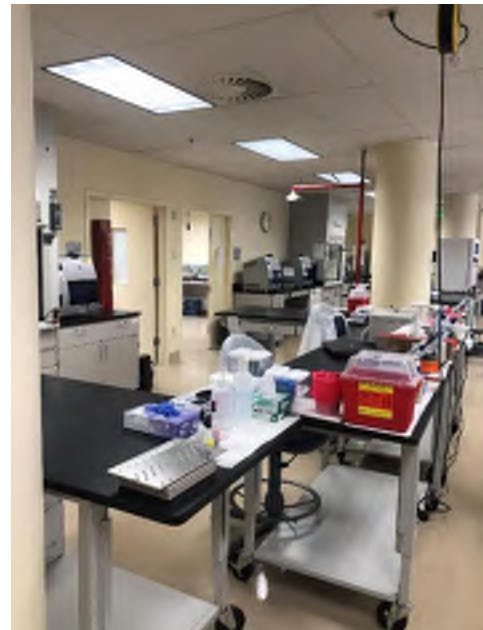
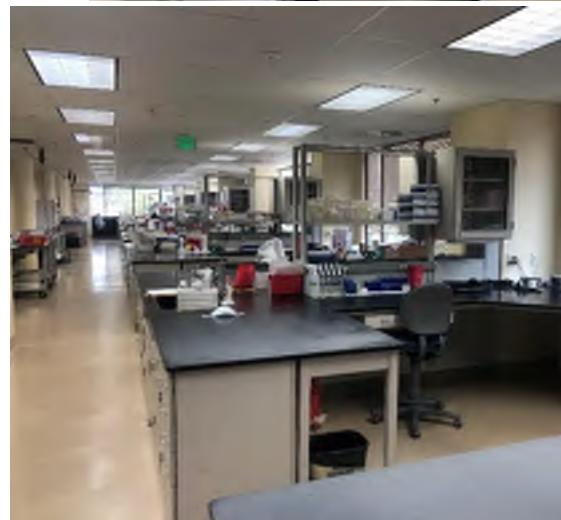
DNA Lab

The adjacent Extraction, PCR Set-Up, and Post-Amplification labs have been adequate for current use; however, fitting the amount of instrumentation in the current benching has been difficult. In the future, it is anticipated that new instrumentation will be smaller in size and will mostly be accommodated in the current space.

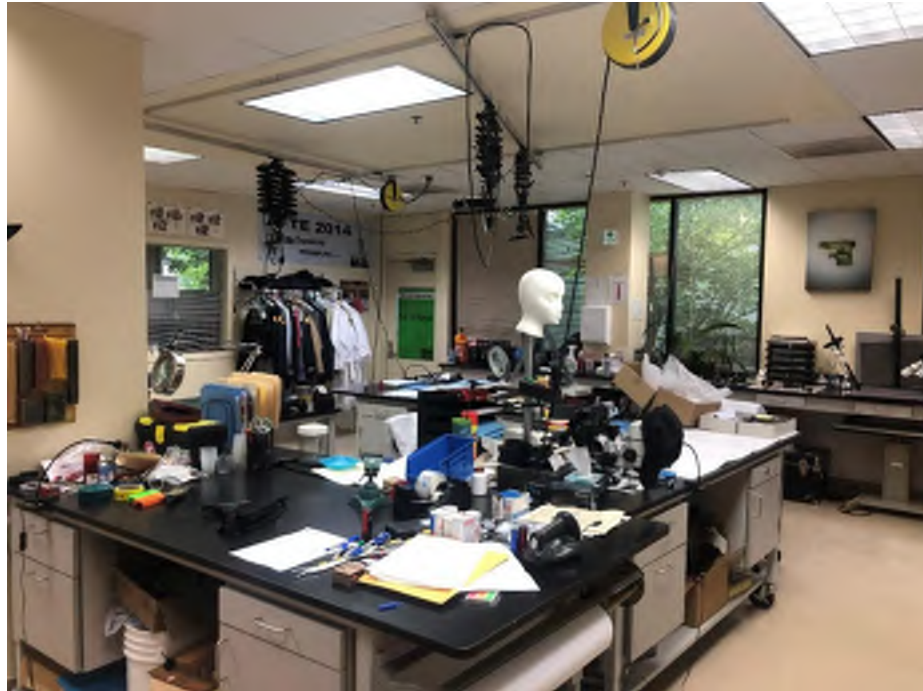
FA Open Lab

- *Firearms Lab*
Located in the southwest corner of the second floor, this lab supports four scientists and one lab tech. It has an open lab area with two adjacent exam rooms and two work areas. Additionally, it has an NIBIN/IBIS lab and storage for reference weapons. In general, the workspaces in the FA Lab are crowded and need to be expanded/modified and adequate administrative space provided for each scientist. The Caswell range is not directly adjacent to the lab and requires exiting the lab space to the exterior to access the range.

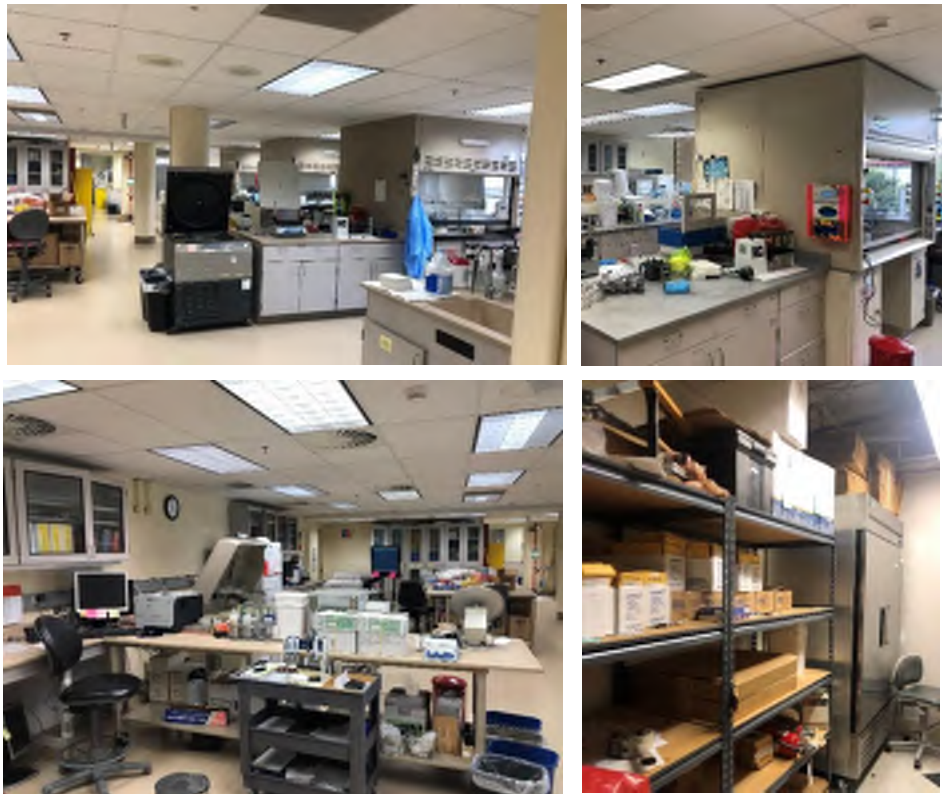
Toxicology Lab

The Instrument lab supporting Toxicology is crammed with equipment and lacks bench space to accommodate needed instrumentation. This lack of instrument space results in less efficient testing of casework, resulting in an overall increase in turnaround time and backlog. The supporting utilities have lacked capacity to serve/cool the current instruments which were unable to operate due to insufficient compressed air.

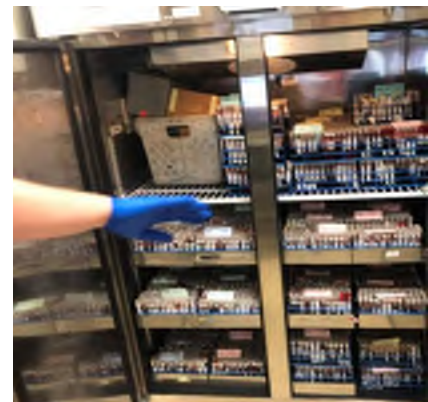
Cold storage at capacity

Evidence processing and storage serving the Toxicology Lab is greatly undersized. Since 2012, the Tox Lab has incurred a 45% increase in casework that has resulted in a significant increase in the number of individual evidence items that need to be processed and stored within the Lab – currently, several ‘overflow’ refrigerators are temporarily housed in laboratory vestibules (entrances to the general laboratory areas). This has a negative impact on the efficiency and operations of evidence processing, storage, and retrieval. Additionally, lab space has been taken for evidence processing.

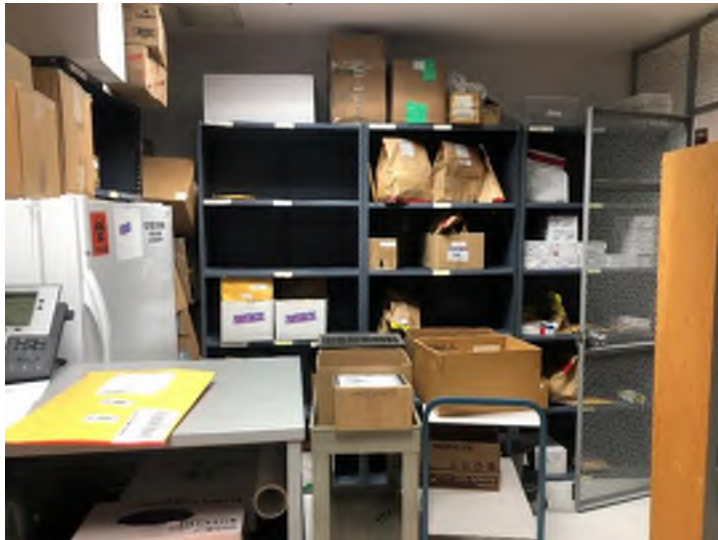
Evidence storage with processing carts

- *Public Access*
There is little or no public access to the lab except for served agencies and delivery services dropping off evidence parcels.
- *Evidence*
The intake is provided with a secure vestibule/corridor lobby. There is no room provided for evidence viewing. Evidence processing takes place on carts in the administrative work area. The main evidence storage area is undersized and does not accommodate current need. There is a walk-in freezer in the evidence room that is adequate for need.

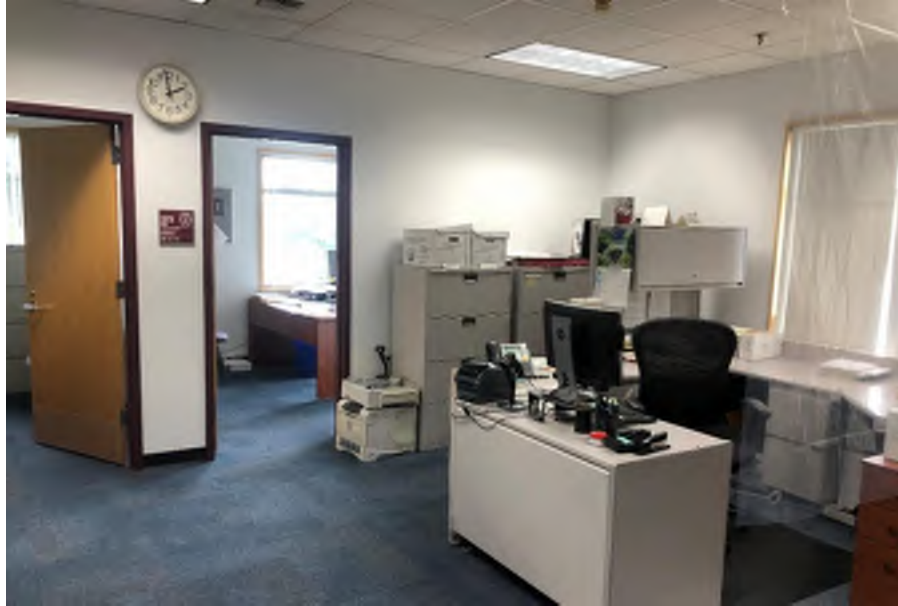
Property Custodian work area & Lab Manager office

- *Administrative Space*
Five enclosed offices are provided for the Lab Manager and supervising scientists with the remainder of administrative space being workstations within the lab areas. There is minimal space for scientists to accomplish their administrative tasks and little or no room for storage of supporting material. Office areas are cramped and congested and there is no room to accommodate any program or personnel growth.

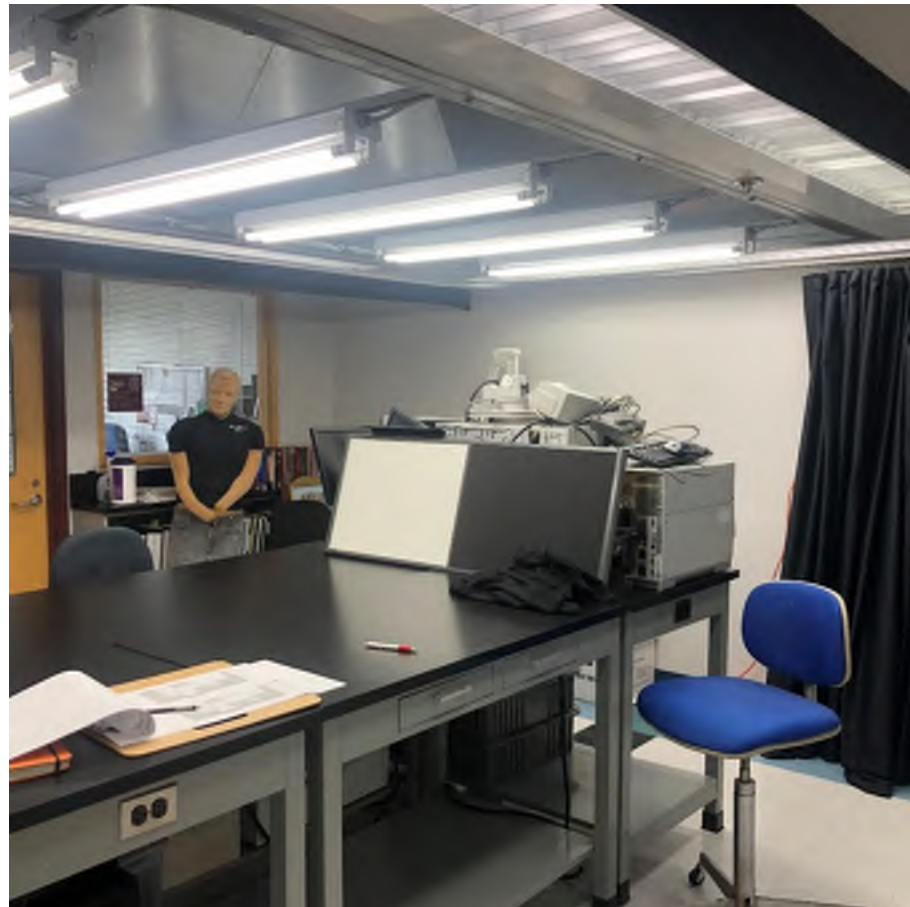
Exam area with light-blocking curtain and vent hood above

- *Insufficient Personnel Support Space*
There are no break room or personnel support spaces. Staff are provided lockers in the corridor.
- *Exam Rooms*
There is no dedicated exam room. An area of the open lab can be divided with a curtain if special lighting is needed for analysis. This area also has a large vent hood above it to exhaust noxious odors.

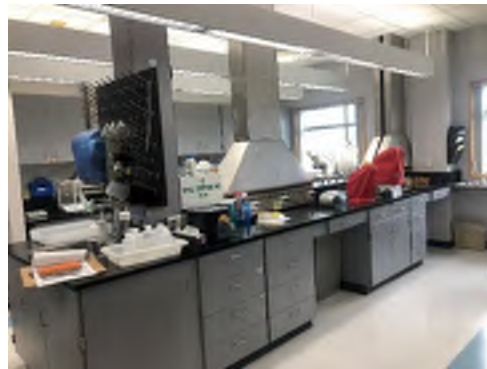
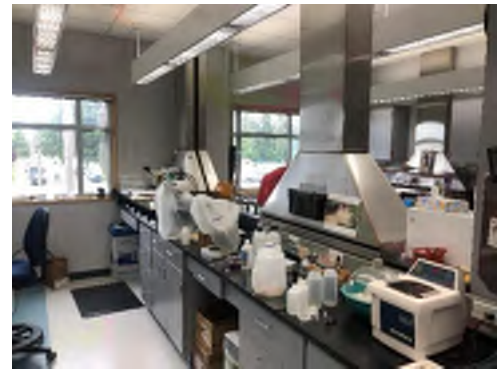
MA/Chemistry Lab

- *Microanalysis/Trace/Chemistry Lab*
The MA and Chemistry functions are “blended” at the lab owing to the lack of separate spaces for these functions. This area of the lab was renovated in 2011 and, with the exception of inadequate size, appears to function adequately.

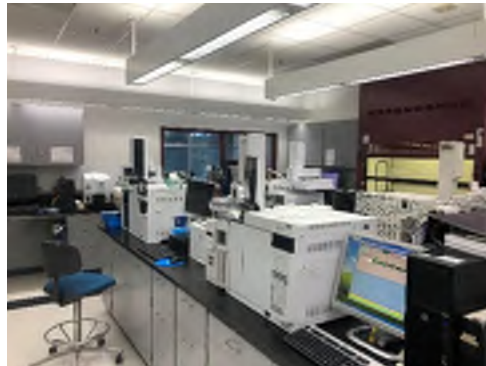
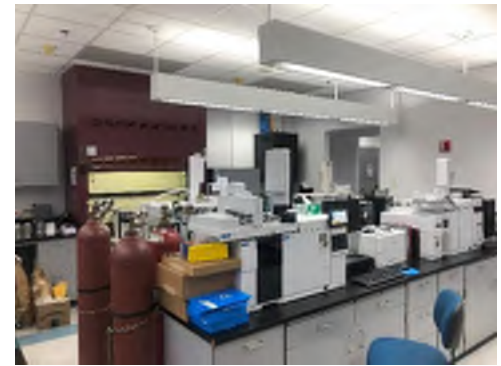
Instrument Room

The adjacent instrument room functions for current need but has no capability for increasing equipment in support of staffing growth.

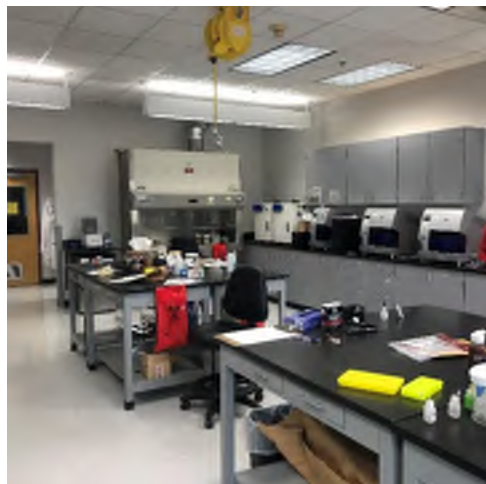
DNA Lab

The DNA lab area provides fixed casework at the perimeter and movable tables at the center. It accommodates six scientists and one lab tech. The adjacent Extraction, PCR Set-Up, and Post-Amplification labs have been adequate for current use

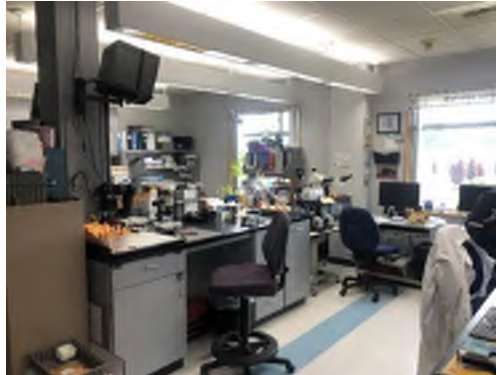
Firearms Lab with office workspace within lab

This this lab supports four scientists and one lab tech. It is crowded and needs to be expanded/modified and separate administrative space provided for each scientist. There is a Caswell range trailer located in the secure parking lot.
